WAVERLEY COUNCIL

Coastal Risks and Hazards Vulnerability Study

301015-02526-CS-REP-0001

December 2011

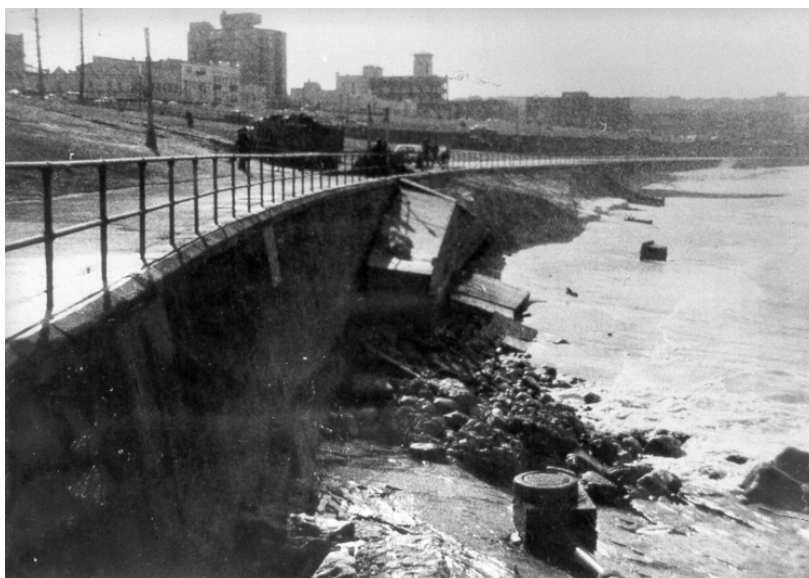
One of the most significant storm events that affected the study area occurred in 1974. Further information on storms within the study area is given in **Section 3.1.3**. **Figure 2.8** shows the 1974 storm damage at the southern end of the beach. **Figure 2.9** provides a summary of the damage that occurred during the 1974 storm throughout the study area.

Figure 2.8 Southern end of Bondi Beach following 1974 storms

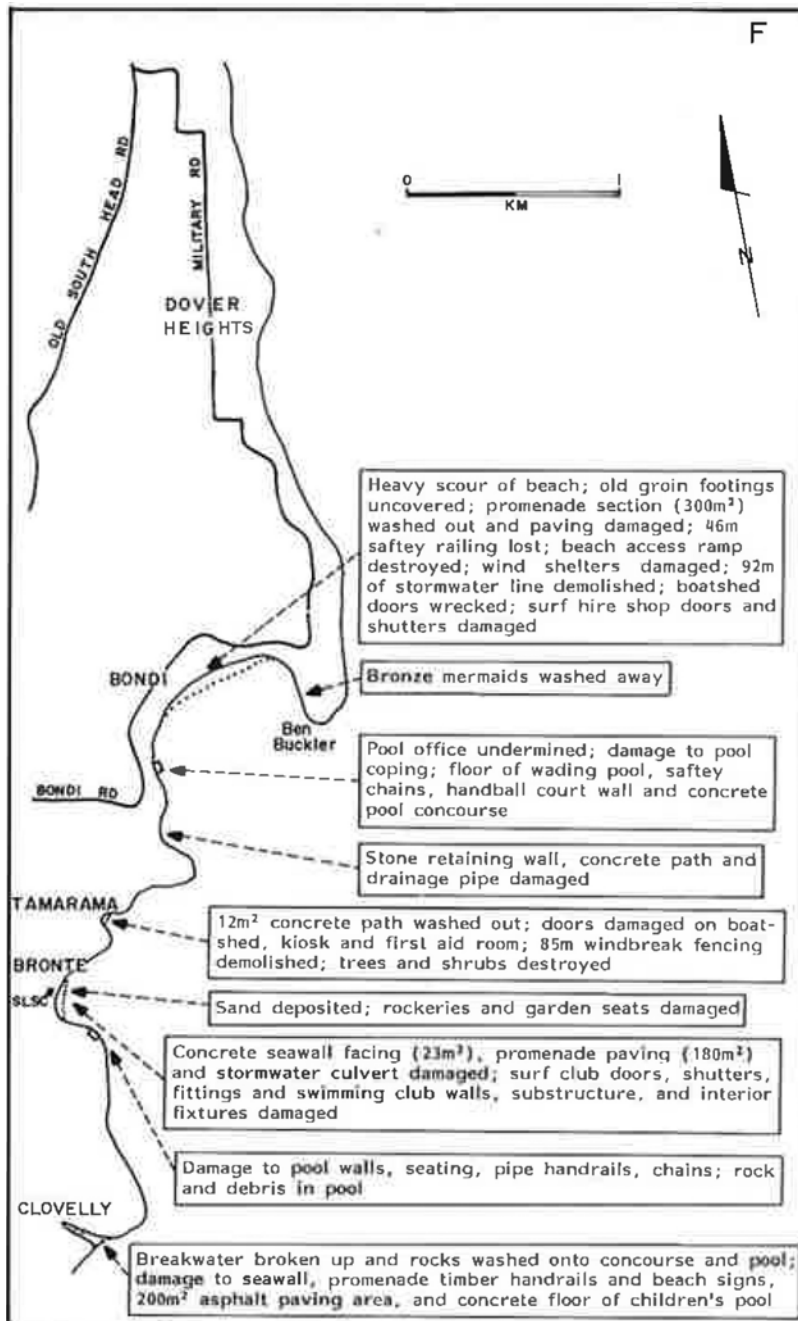
Figure 2.9 1974 Storm damage (Source: Chapman *et al.* 1982)

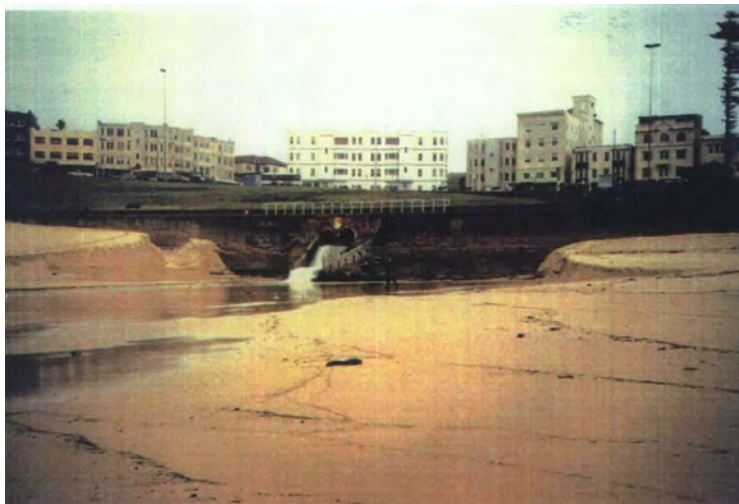
Following the 1974 storms, improvements were made to the seawall, with the construction of a Reno-mattress toe (refer **Figure 2.11** and **Figure 3.16**). The work was undertaken in stages from 1987 to 1992, by which time the entire length of the seawall had been reinforced. In the late 1980's the box culvert stormwater outfall was constructed in the south of the beach (refer **Figure 3.6**). Prior to that two large stormwater pipes (1260mm and 1350mm diameter) discharged onto the beach at the southern end, which caused scour during high flows (refer **Figure 2.10**).

Figure 2.10 Old stormwater outfall, showing beach scour following storm event August 1986
(source PWD 1988)

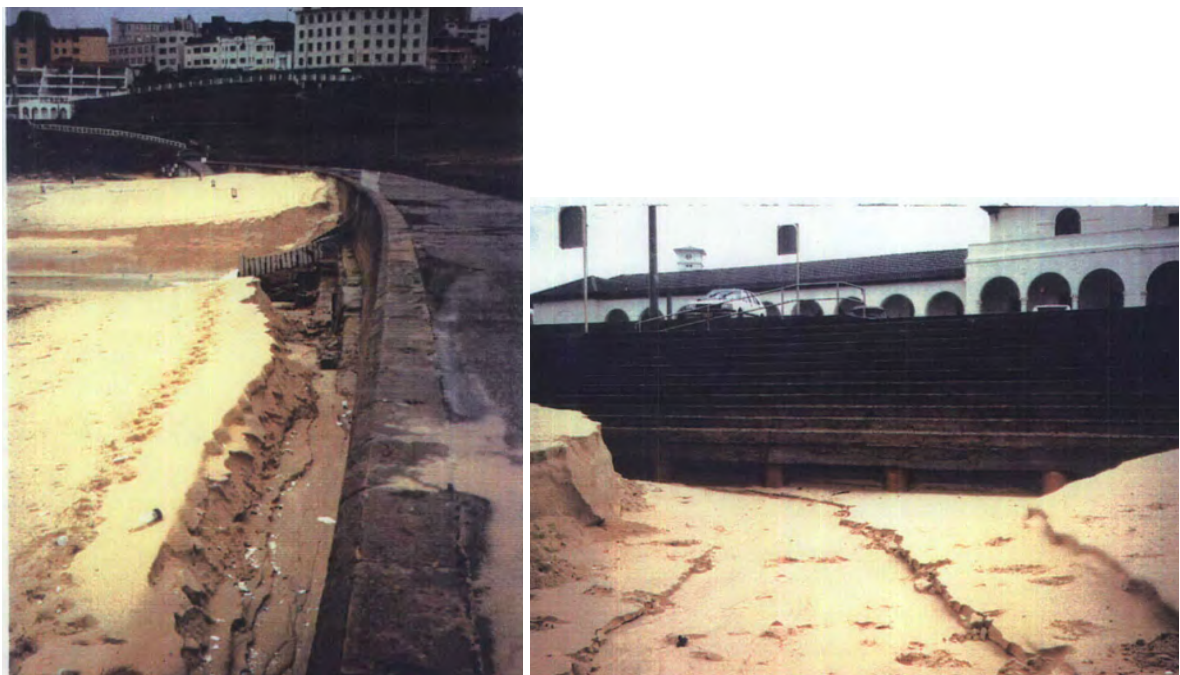
Figure 3.11 Scour along the seawall and steps leading to the pavilion, from surface water runoff during August 1986 storm. Note that the stormwater outlet shown in the left photo no longer exists. (Source: PWD 1988)

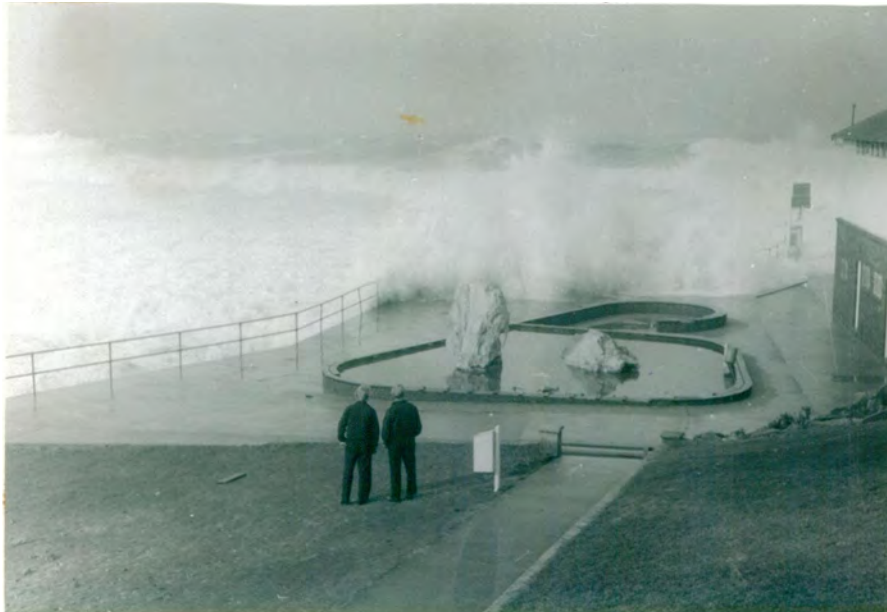
Figure 3.12 Overtopping at Bronte, 1974 (source: Waverley Council)

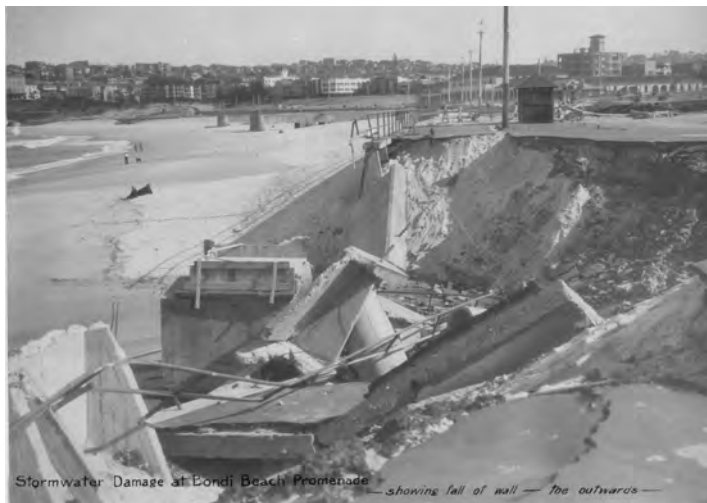
Figure 3.15 Bondi Northern Seawall Failure, 1929 (Source: Waverley Council)

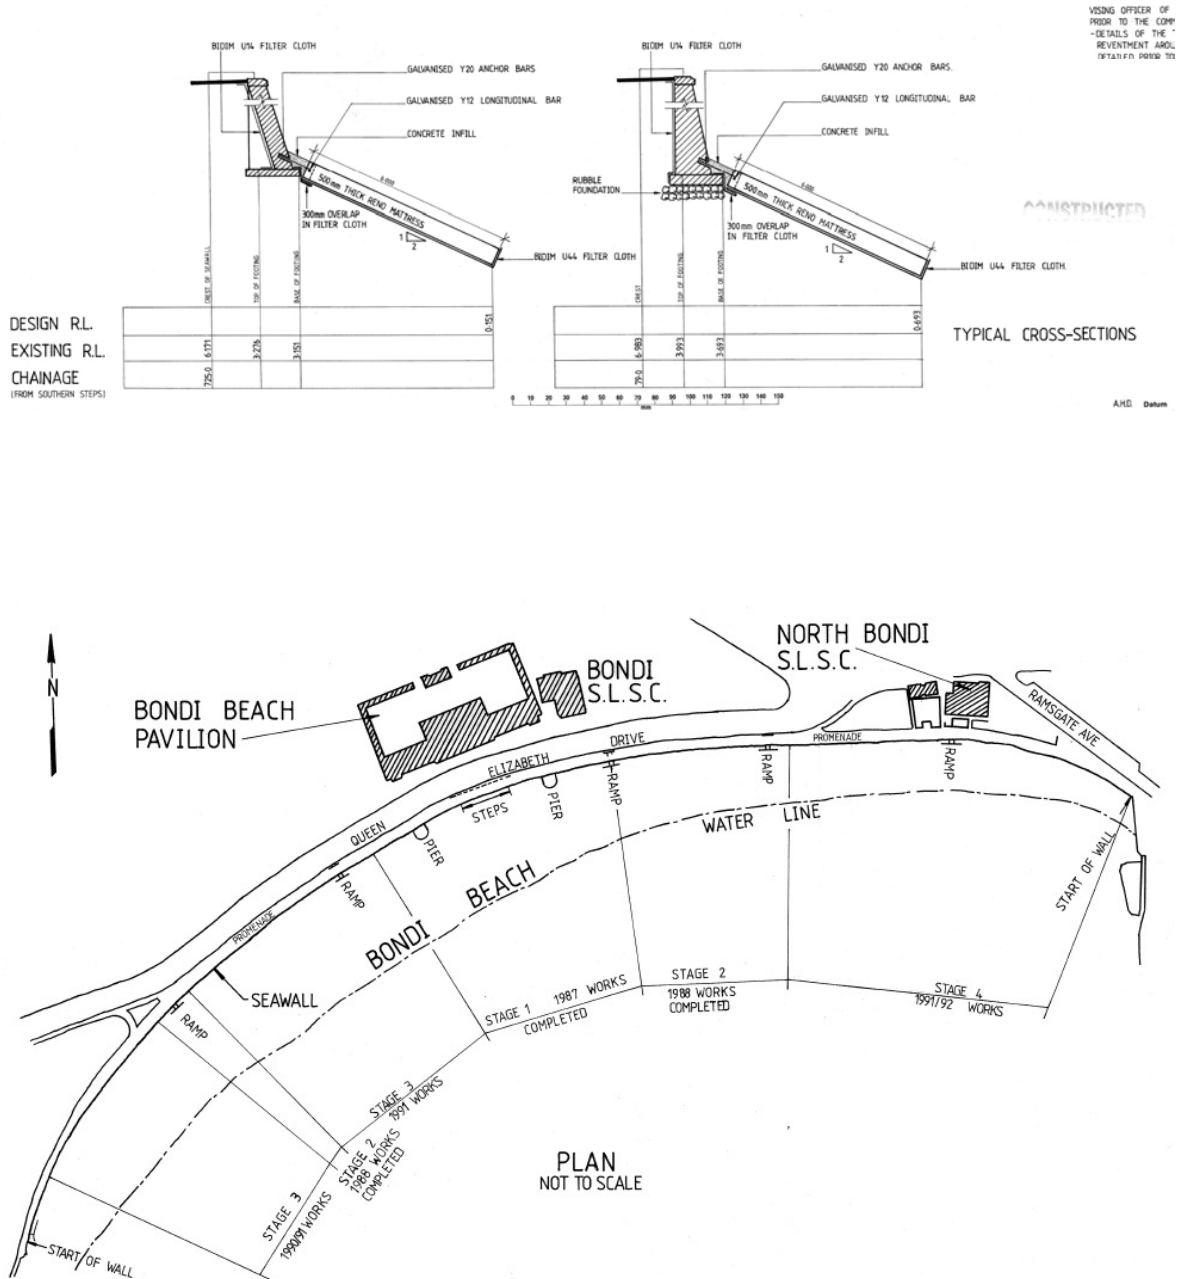
Figure 3.16 Bondi Seawall Toe Improvement works. Typical sections (top); Extent of works (bottom) (Source: Council plan dated 18-1-89)

These original seawall structures still exist today although some repair works have been undertaken. Two key works on the seawall were undertaken in the late 1980's and early 1990's. These included relocating the stormwater outlet in the south of the seawall to the southern headland and construction of a Reno-mattress at the toe of the seawall. The construction drawings for the stormwater improvements, dated 1986, detailed the demolition of the existing concrete apron, infilling and sealing the old outfall pipes and construction of a new concrete box culvert discharging onto the rocks at the southern headland. Details of the Reno-mattress toe protection works were provided by Council (**Figure 3.16**). Construction photos (**Figure 2.11**) and "as constructed" drawings provided by Council indicated that construction along the entire length of the wall was carried out between 1987 and 1992.

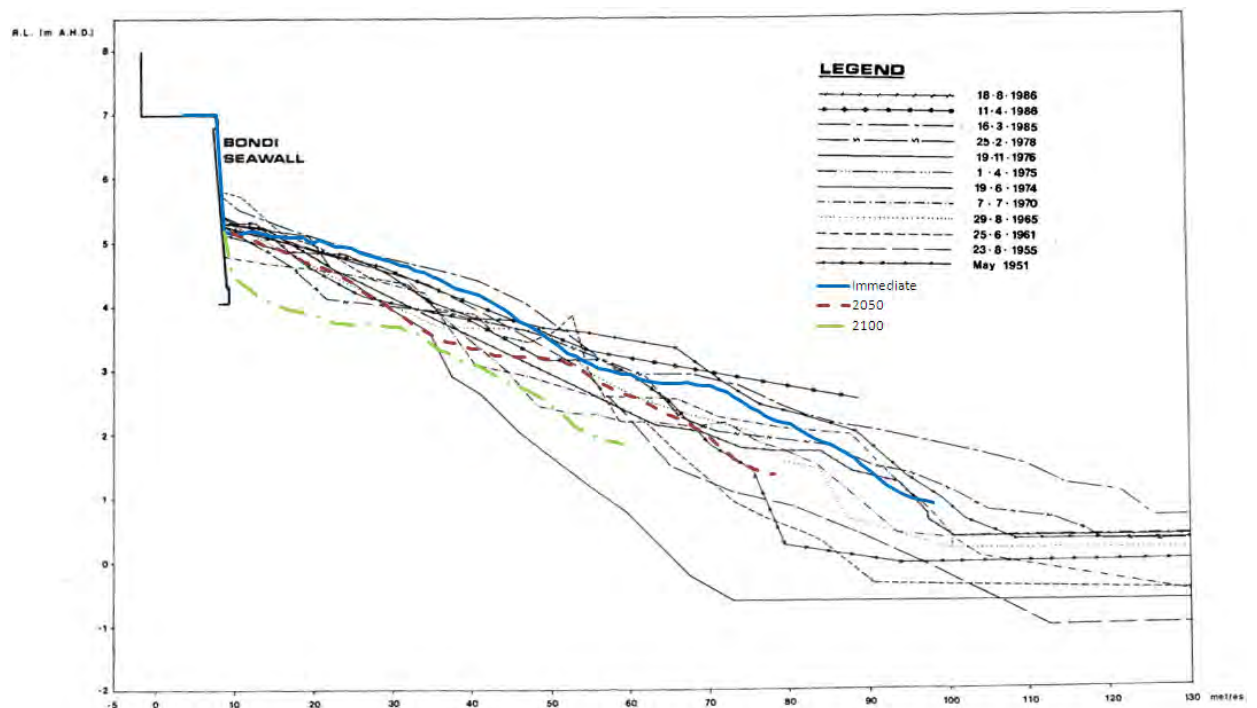
In 2100, with a rise in sea level of 0.9 m, the water line would recede some 45 m from its present day position but the profile would rise by 0.9 m. The volume of sand in front of the wall and above 0.9 m AHD would be 120 m³/m. For a storm erosion demand of 220 m³/m, sand would be eroded back to the seawall causing a risk to the stability of the seawall.

Figure 4.3 Historical and predicted profiles for the south of Bondi

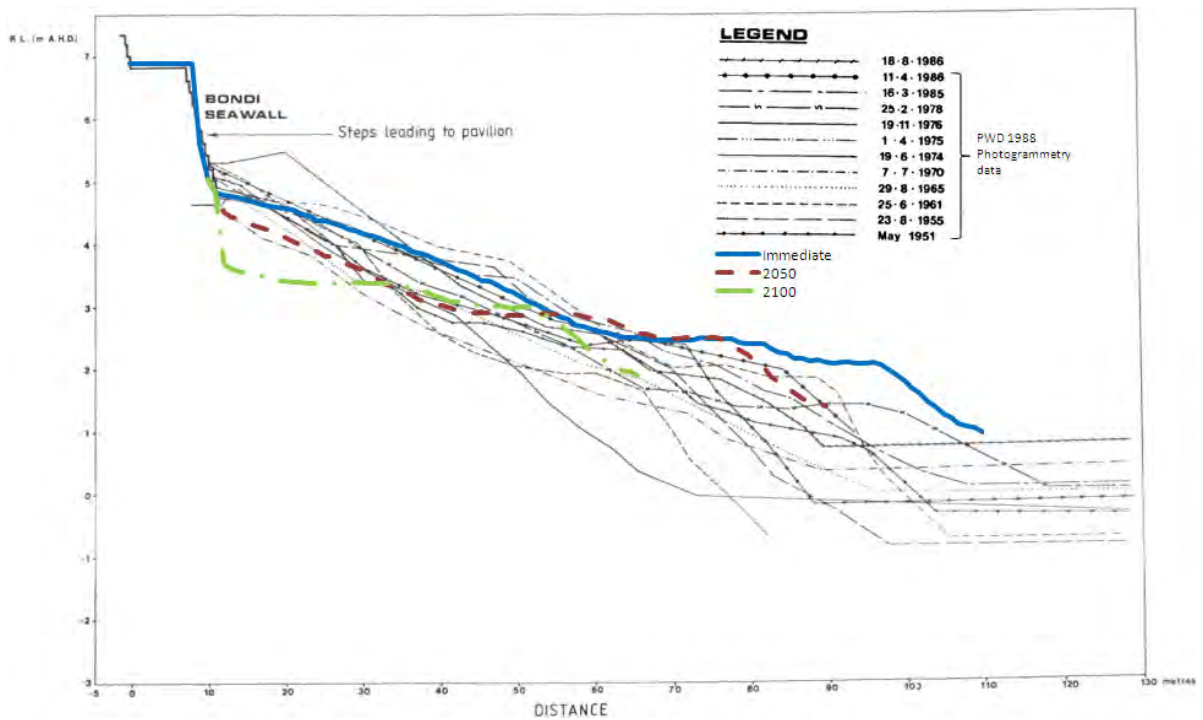
0.9 m AHD could be around 120 m³/m. For a storm erosion demand of 110 m³/m, sand would be little sand in front of the seawall causing a risk to the stability of the seawall.

Figure 4.4 Historical and predicted profiles for the centre of Bondi

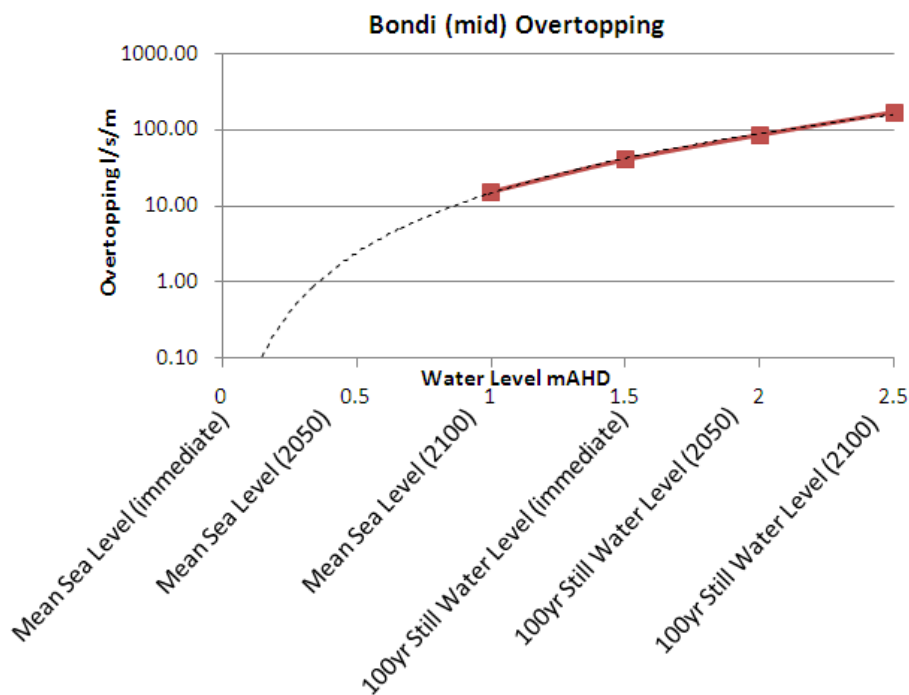
A typical section in the middle of Bondi Beach was assessed for overtopping, with crest level taken as 6.8 m AHD, and the beach level at the toe as the 1974 scour levels. The wave conditions adopted were those for the 6 hour duration wave height that had a 5% risk of being exceeded over the next 50 years. The waves applied were depth limited to the scoured beach level, and a range of wave periods were applied. That is to say that the overtopping estimates relate to extreme wave conditions applied to an eroded beach state. **Figure 4.9** shows a summary of these results for various water levels. It can be seen that for an immediate 100 yr ARI still water level the overtopping value is well over the 0.3 l/s/m suggested as dangerous for pedestrians and for 2050 and 2100 (100 yr still water level) the overtopping increases. As the seawall crests at Bronte and Tamarama are lower than at Bondi, it would be expected that the overtopping would be greater. Recommendations for management measures are discussed in **Section 4.7**.

Figure 4.9 Potential Average Overtopping Values for Typical Section in the middle of Bondi, for Extreme Scour and a Range of Water Levels (dashed line in an estimated trend line)

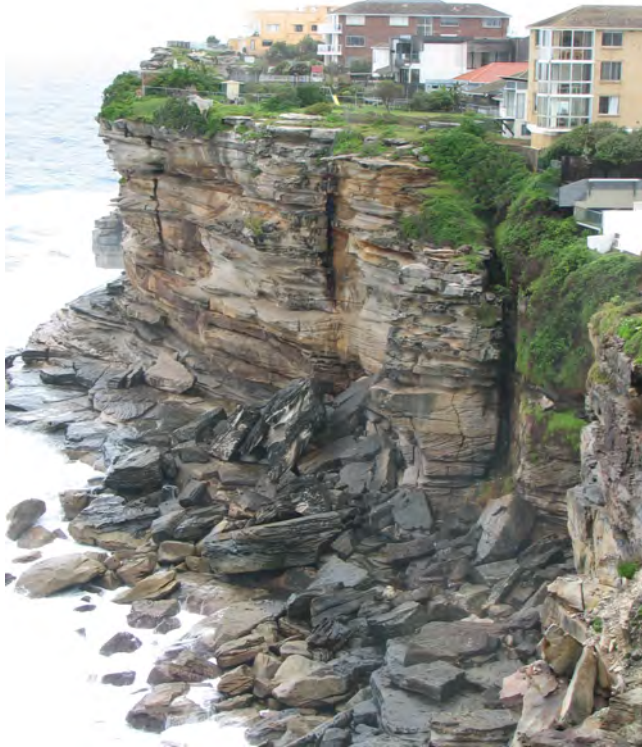
Figure 5.1 Cliff face failure onto wave cut platform

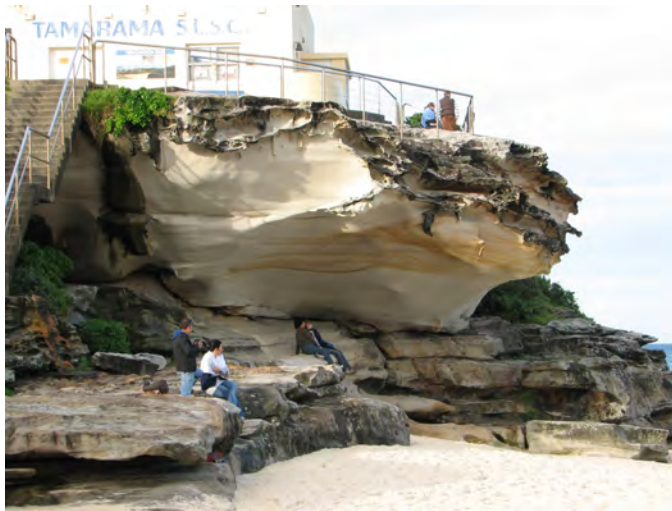
In addition, similar differential weathering and erosion (by wave and wind action) of relatively weak sub-horizontal XWS, shale bands and clay bands over the cliff faces has led to the formation of the numerous cliff top overhang features identified along the study area and undercut features at the base and over the cliff face (**Figure 5.3**).

Figure 5.3 Cliff top overhang and undercut features

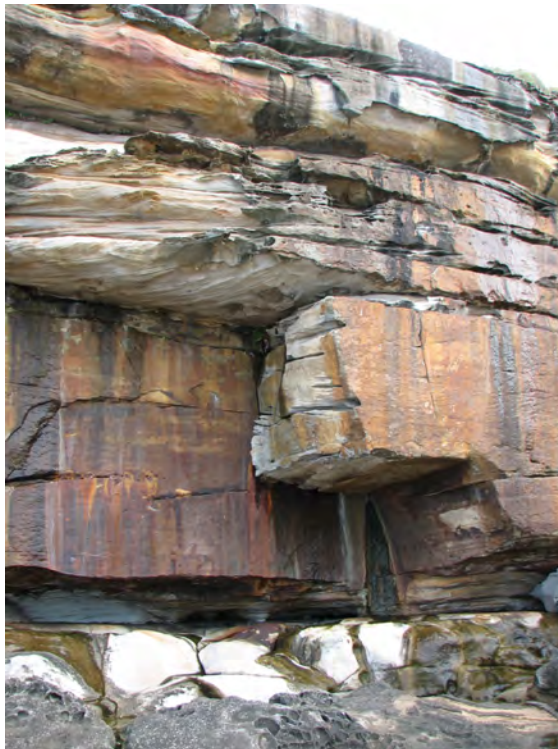
It also appears that the overhangs migrate up the cliff face with sub-horizontal bedding partings and the orthogonal joint sets controlling each successive block collapse (**Figure 5.5**).

Figure 5.5 Upward migrating overhang

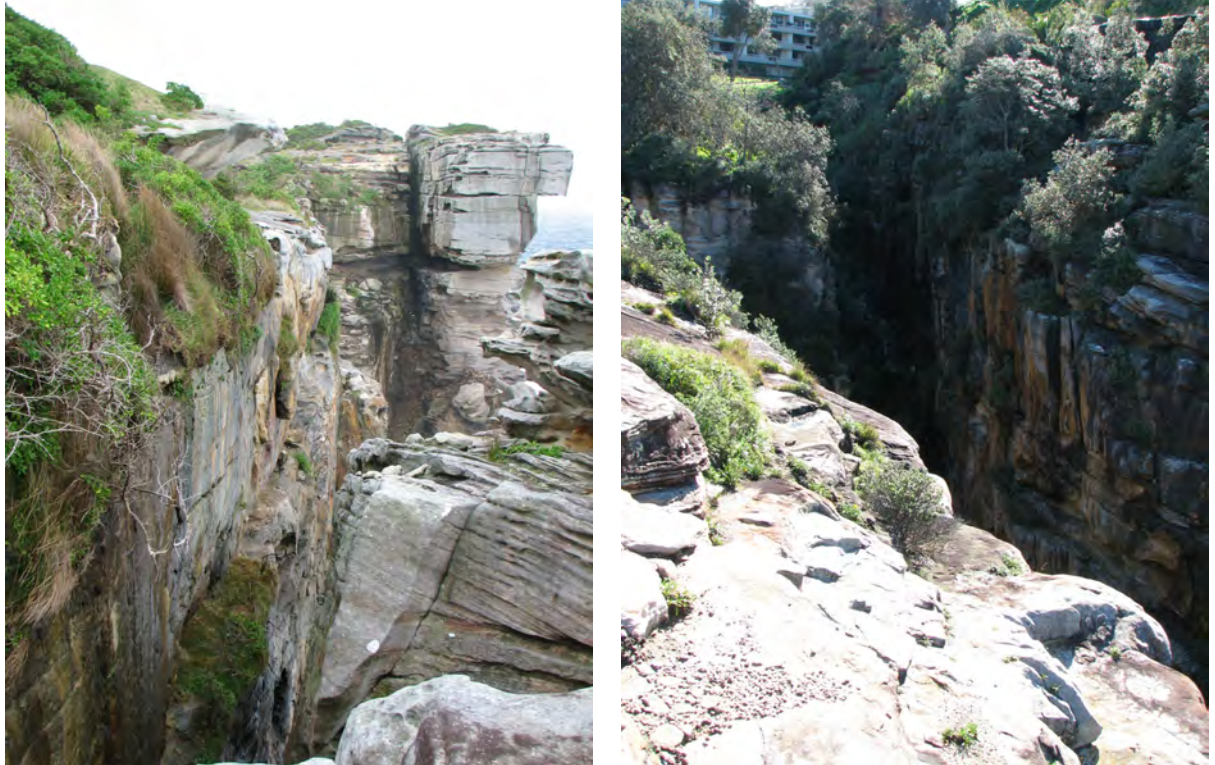
Figure 5.6 Cliff line gullies

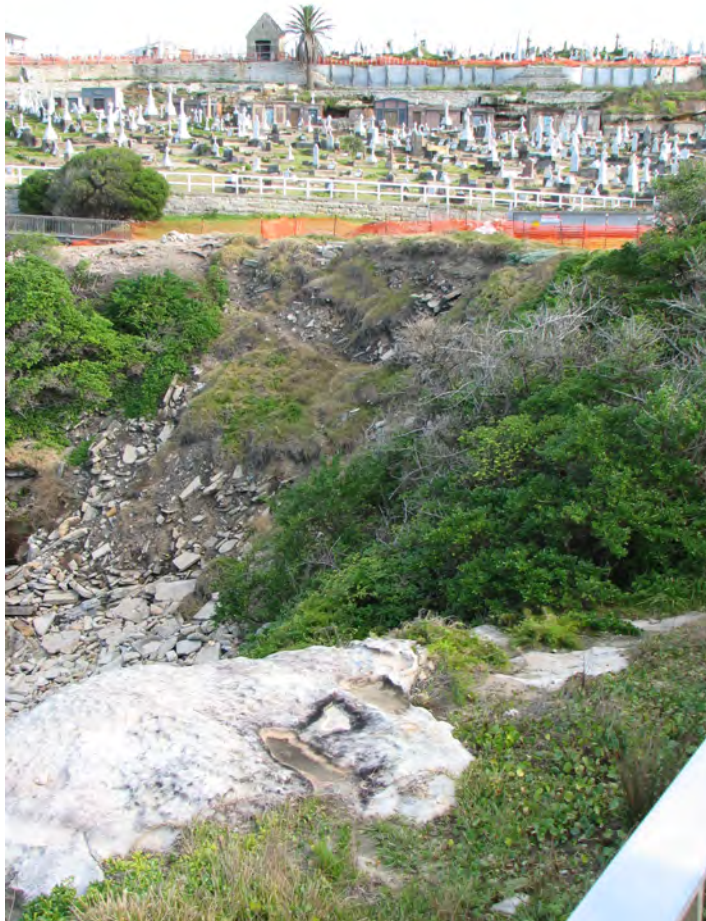
The most dramatic example of a number of these factors affecting one slope was the fill batter slope infill of the gully feature within Waverley Cemetery (**Figure 5.7**).

Figure 5.7 Fill batter slope at Waverley Cemetery
