WAVERLEY COUNCIL

Coastal Risks and Hazards Vulnerability Study

301015-02526-CS-REP-0001

December 2011

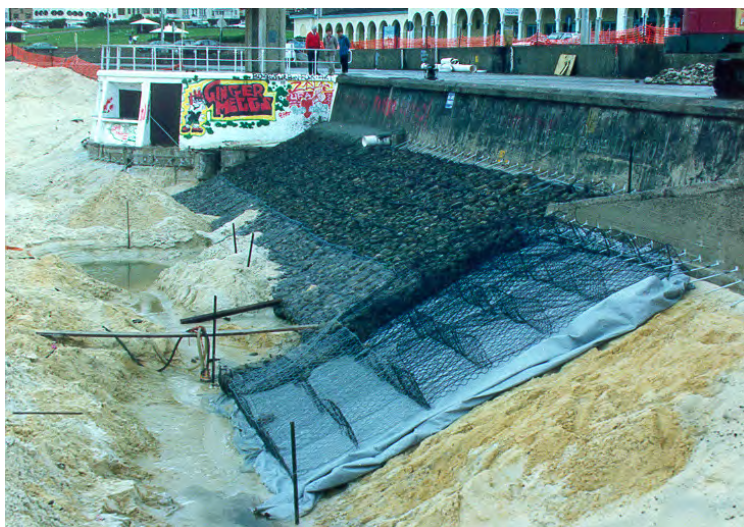
Figure 2.11 Construction of Bondi Seawall, Reno-mattress toe protection works 1987
(Source: Lex Nielsen)

These original seawall structures still exist today although some repair works have been undertaken. Two key works on the seawall were undertaken in the late 1980's and early 1990's. These included relocating the stormwater outlet in the south of the seawall to the southern headland and construction of a Reno-mattress at the toe of the seawall. The construction drawings for the stormwater improvements, dated 1986, detailed the demolition of the existing concrete apron, infilling and sealing the old outfall pipes and construction of a new concrete box culvert discharging onto the rocks at the southern headland. Details of the Reno-mattress toe protection works were provided by Council (**Figure 3.16**). Construction photos (**Figure 2.11**) and "as constructed" drawings provided by Council indicated that construction along the entire length of the wall was carried out between 1987 and 1992.

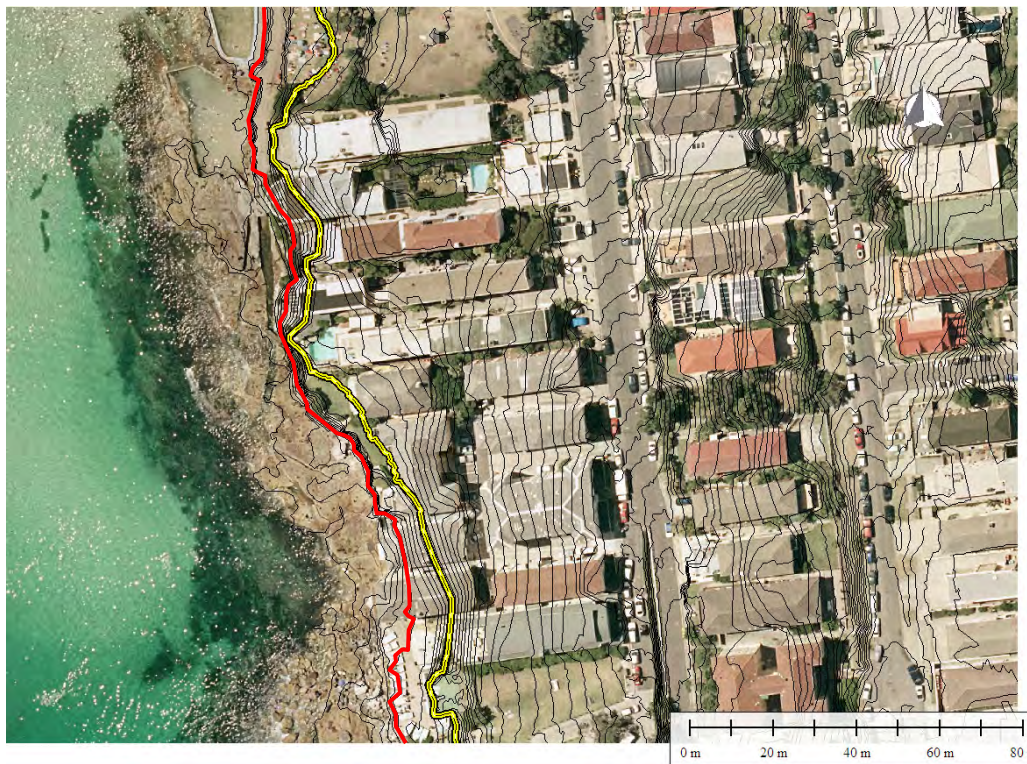
A number of ocean front properties on Ramsgate Avenue could be inundated due to still water levels and wave runup (refer **Figure 4.8**). Levels of inundation have been calculated to be 4.4 m AHD for

2011, 5.4 m AHD for 2050 and 6.6 m AHD for 2100. However, inundation to the buildings is subject to individual floor levels, which could be well above inundation limits.

Figure 4.8 Aerial Photograph of Foreshore Properties at Ramsgate Avenue (red line indicates 3m AHD and yellow line indicates 6m AHD, ground levels)

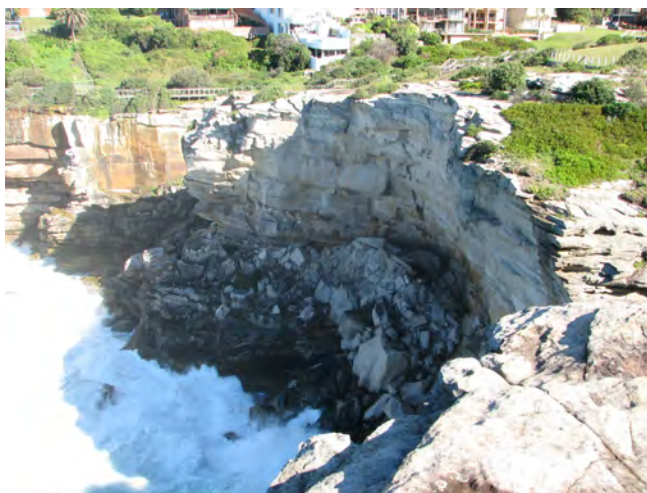
Collapse of these overhangs has also occurred in a similar manner as described above. The rock fall at Diamond Bay (**Figure 5.4**) is believed to be due to such a mechanism although the form of the rock fall appears to have been controlled at least in part by the relatively weaker mass strength of the rock rather than strictly controlled by the orthogonal joint sets. This may be due to localised alteration of the rock mass due to the elevated heat associated with the intrusion of the igneous dykes to the north and south of the rock fall. The alteration appears to have weakened the overall strength of the rock mass in this area.

Figure 5.4 Collapse of cliff face overhang at Diamond Bay

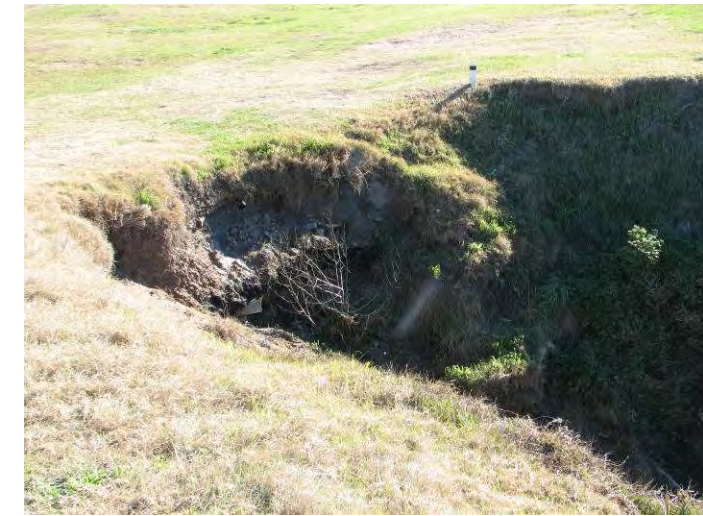
Instability of soil slope

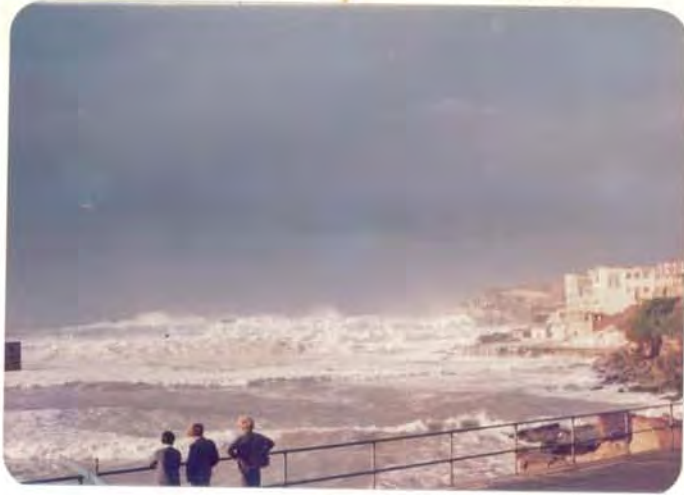
BONDI BEACH STORM DAMAGE 13th JUNE 1974
PHOTOS TAKEN M DOBSON

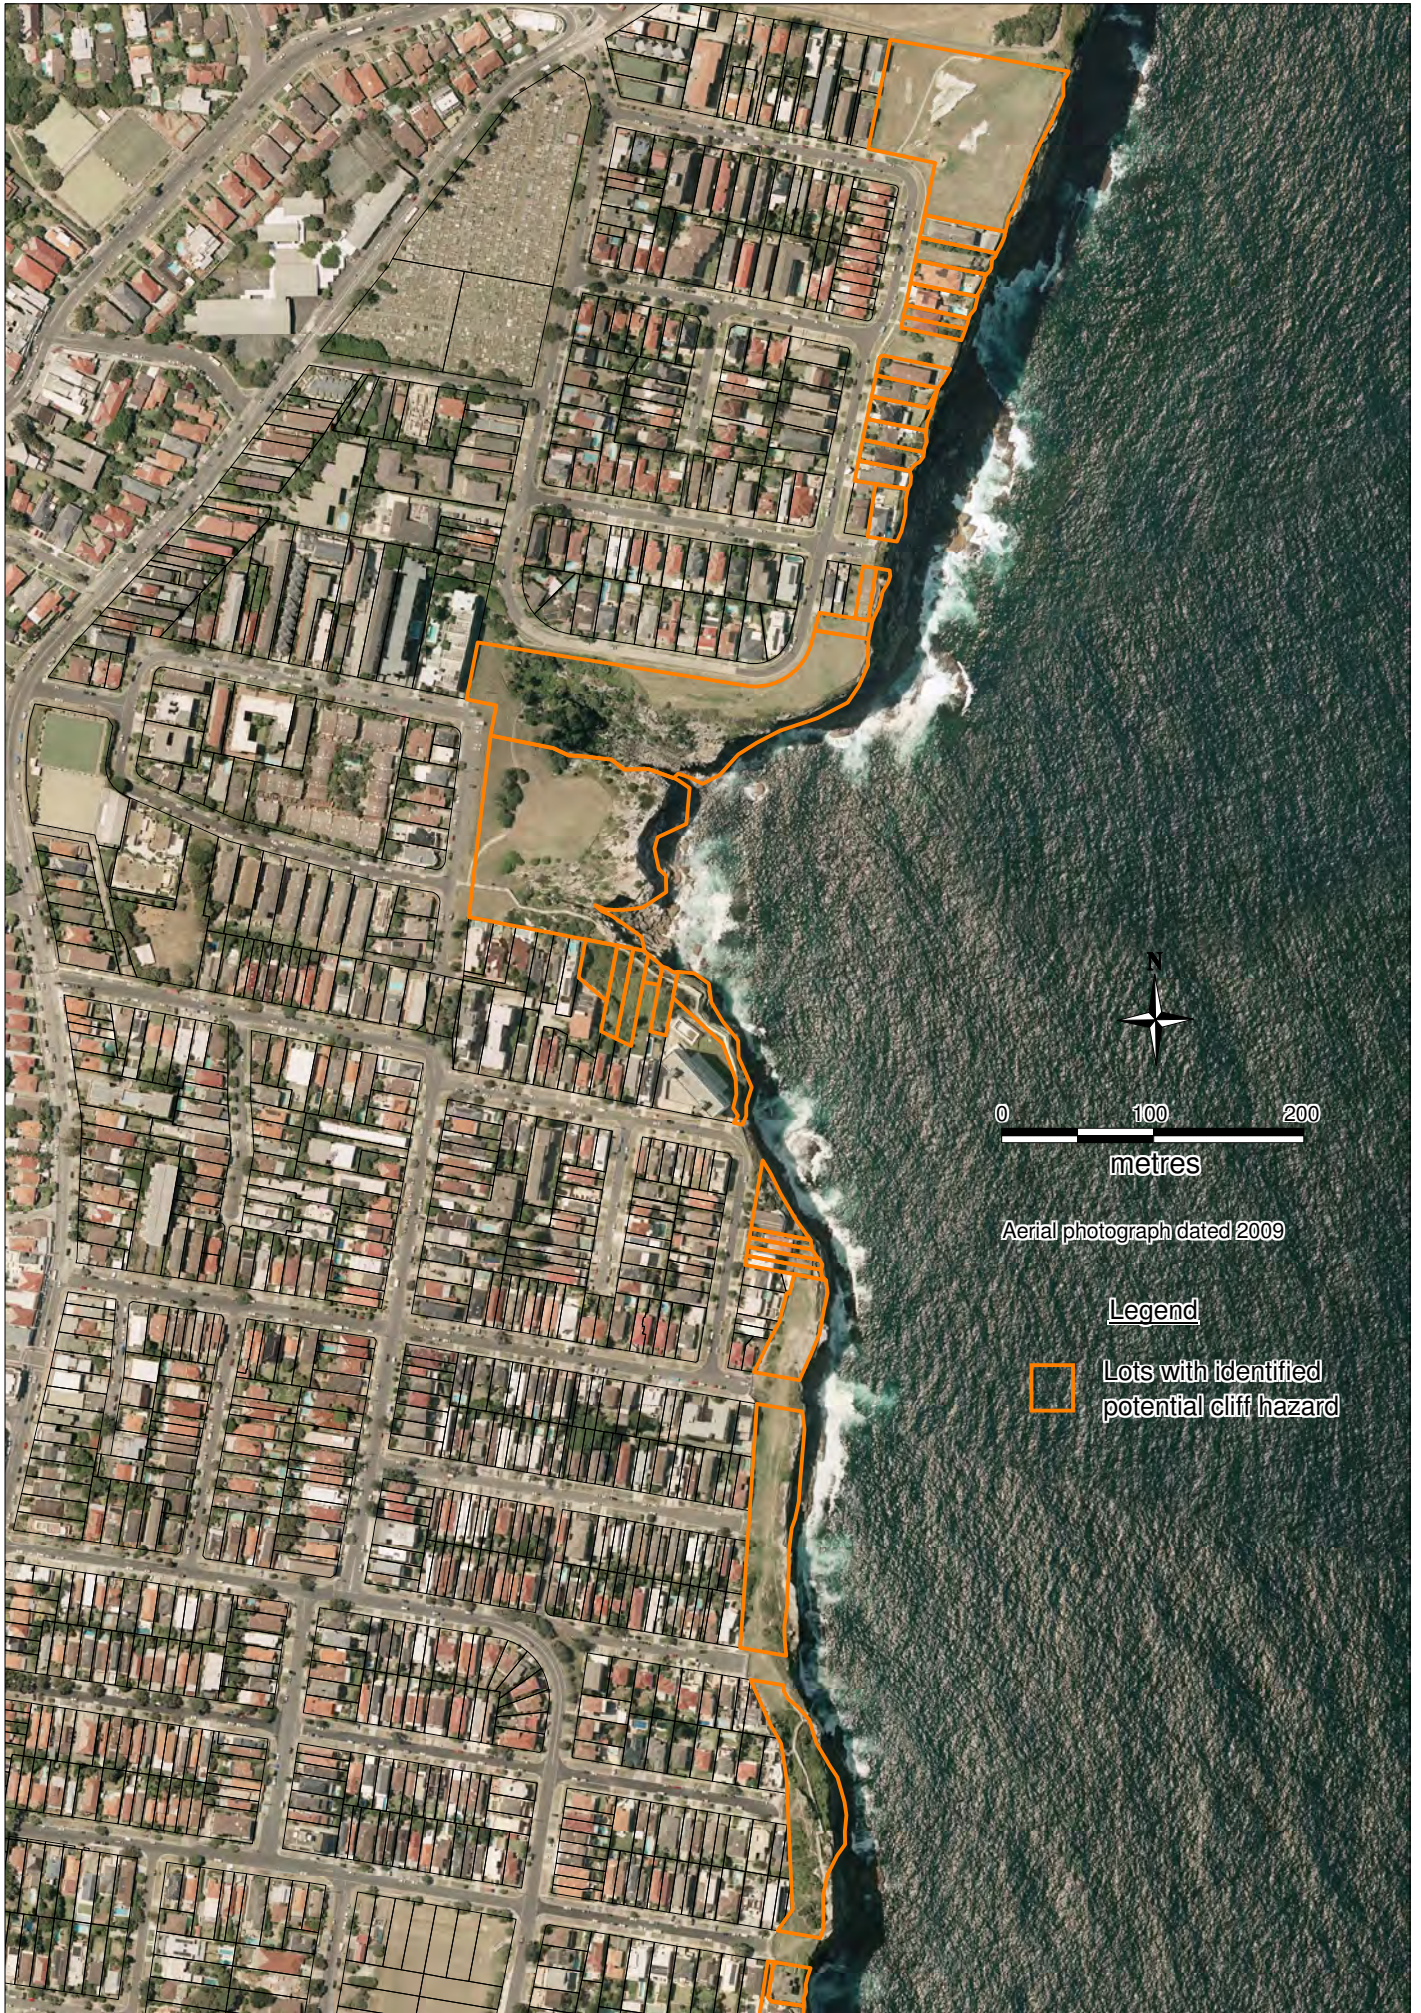
LOTS WITH IDENTIFIED POTENTIAL CLIFF HAZARD (1 OF 6)

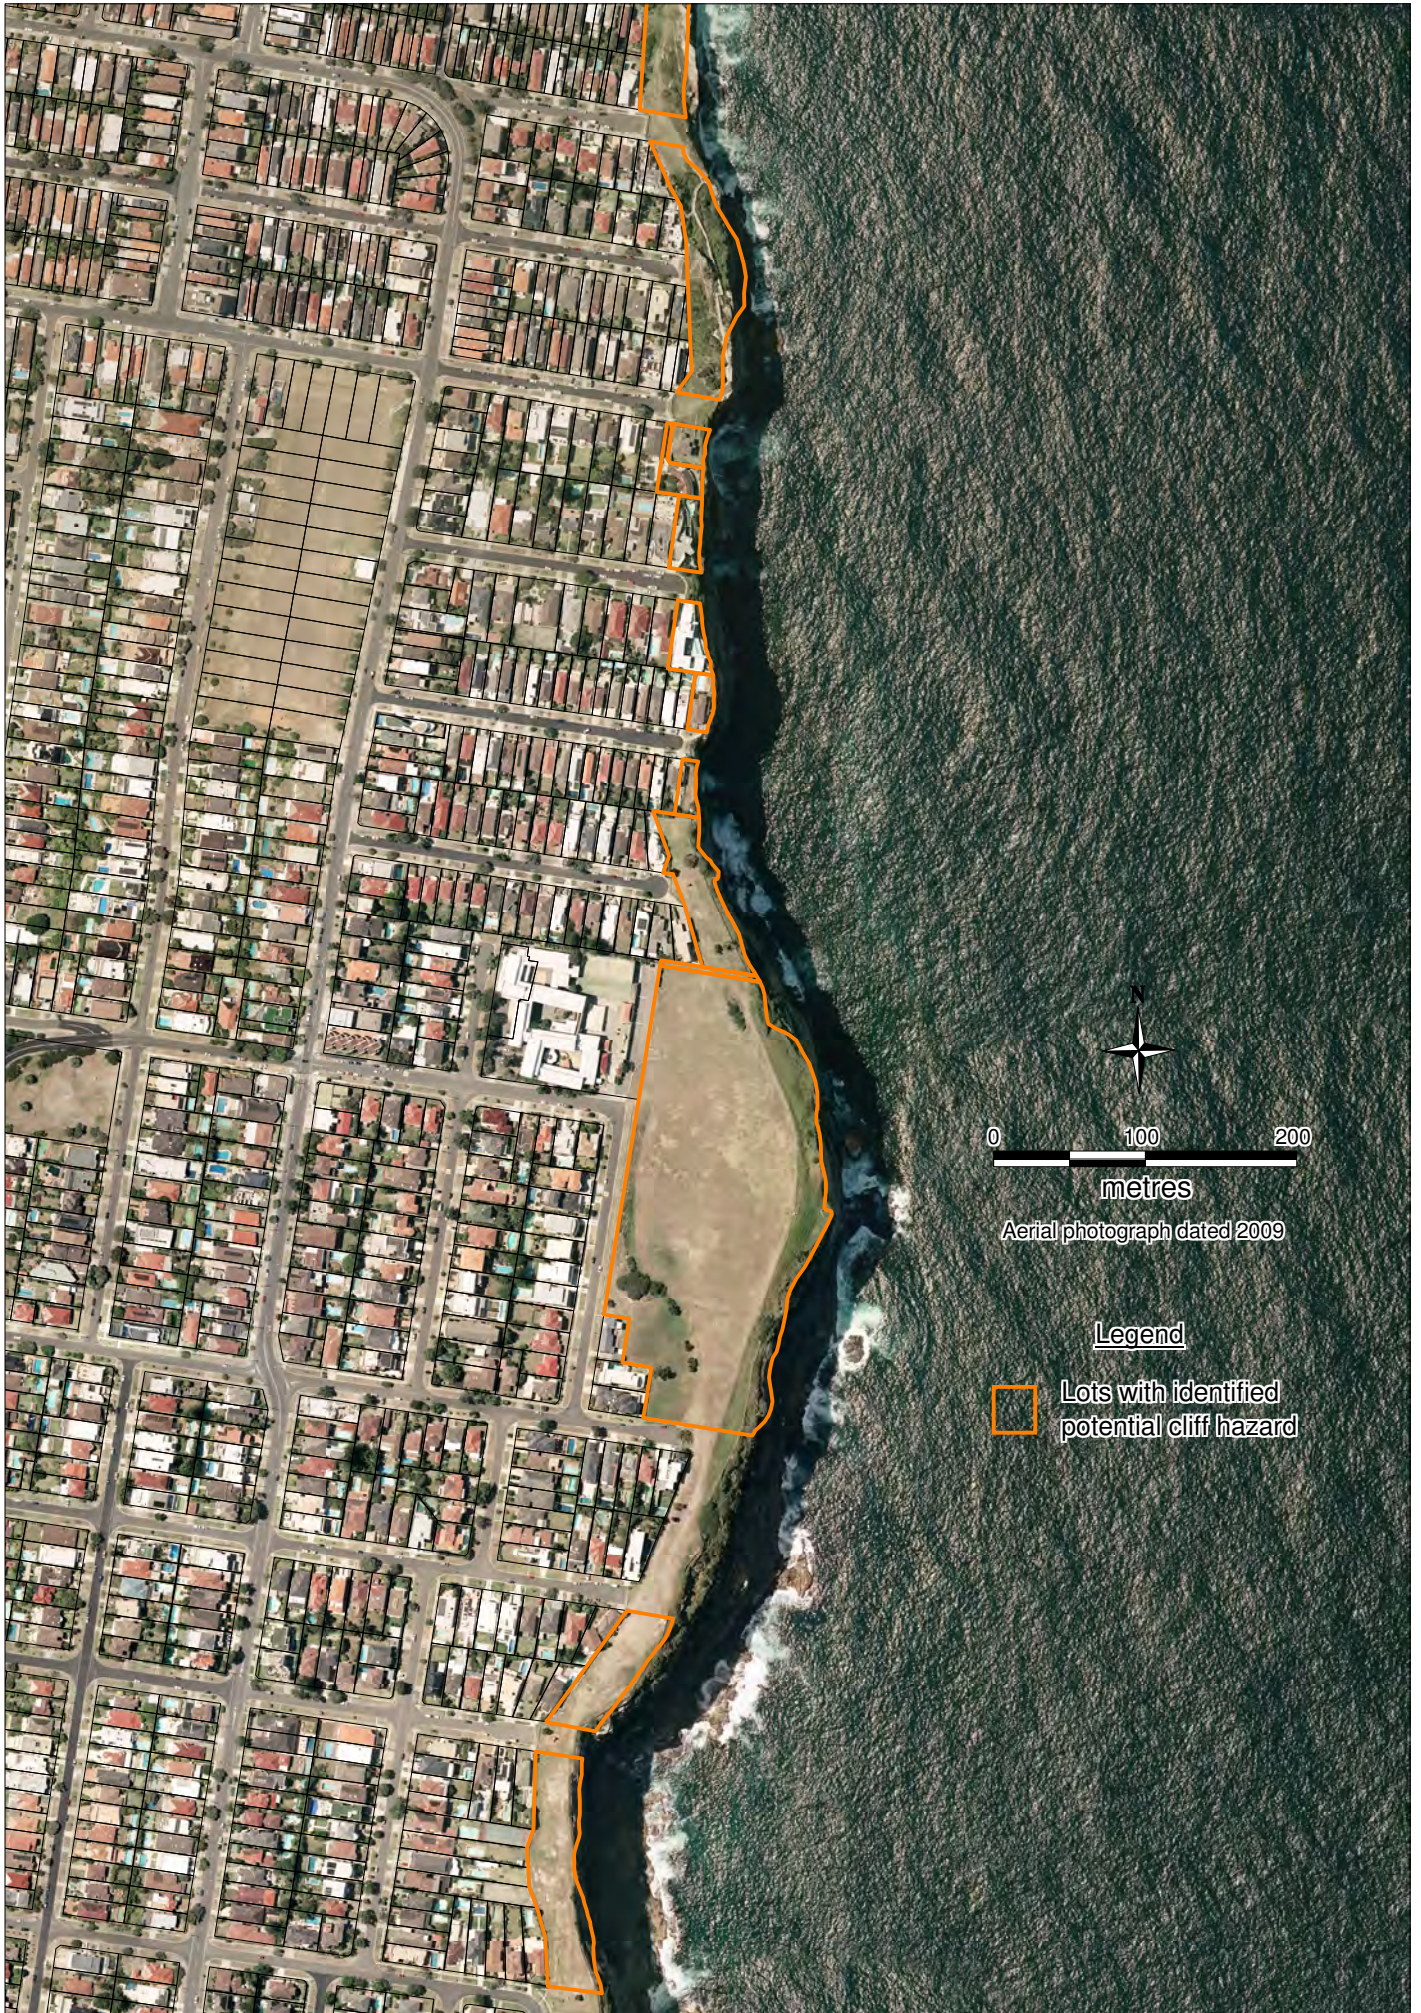
LOTS WITH IDENTIFIED POTENTIAL CLIFF HAZARD (2 OF 6)

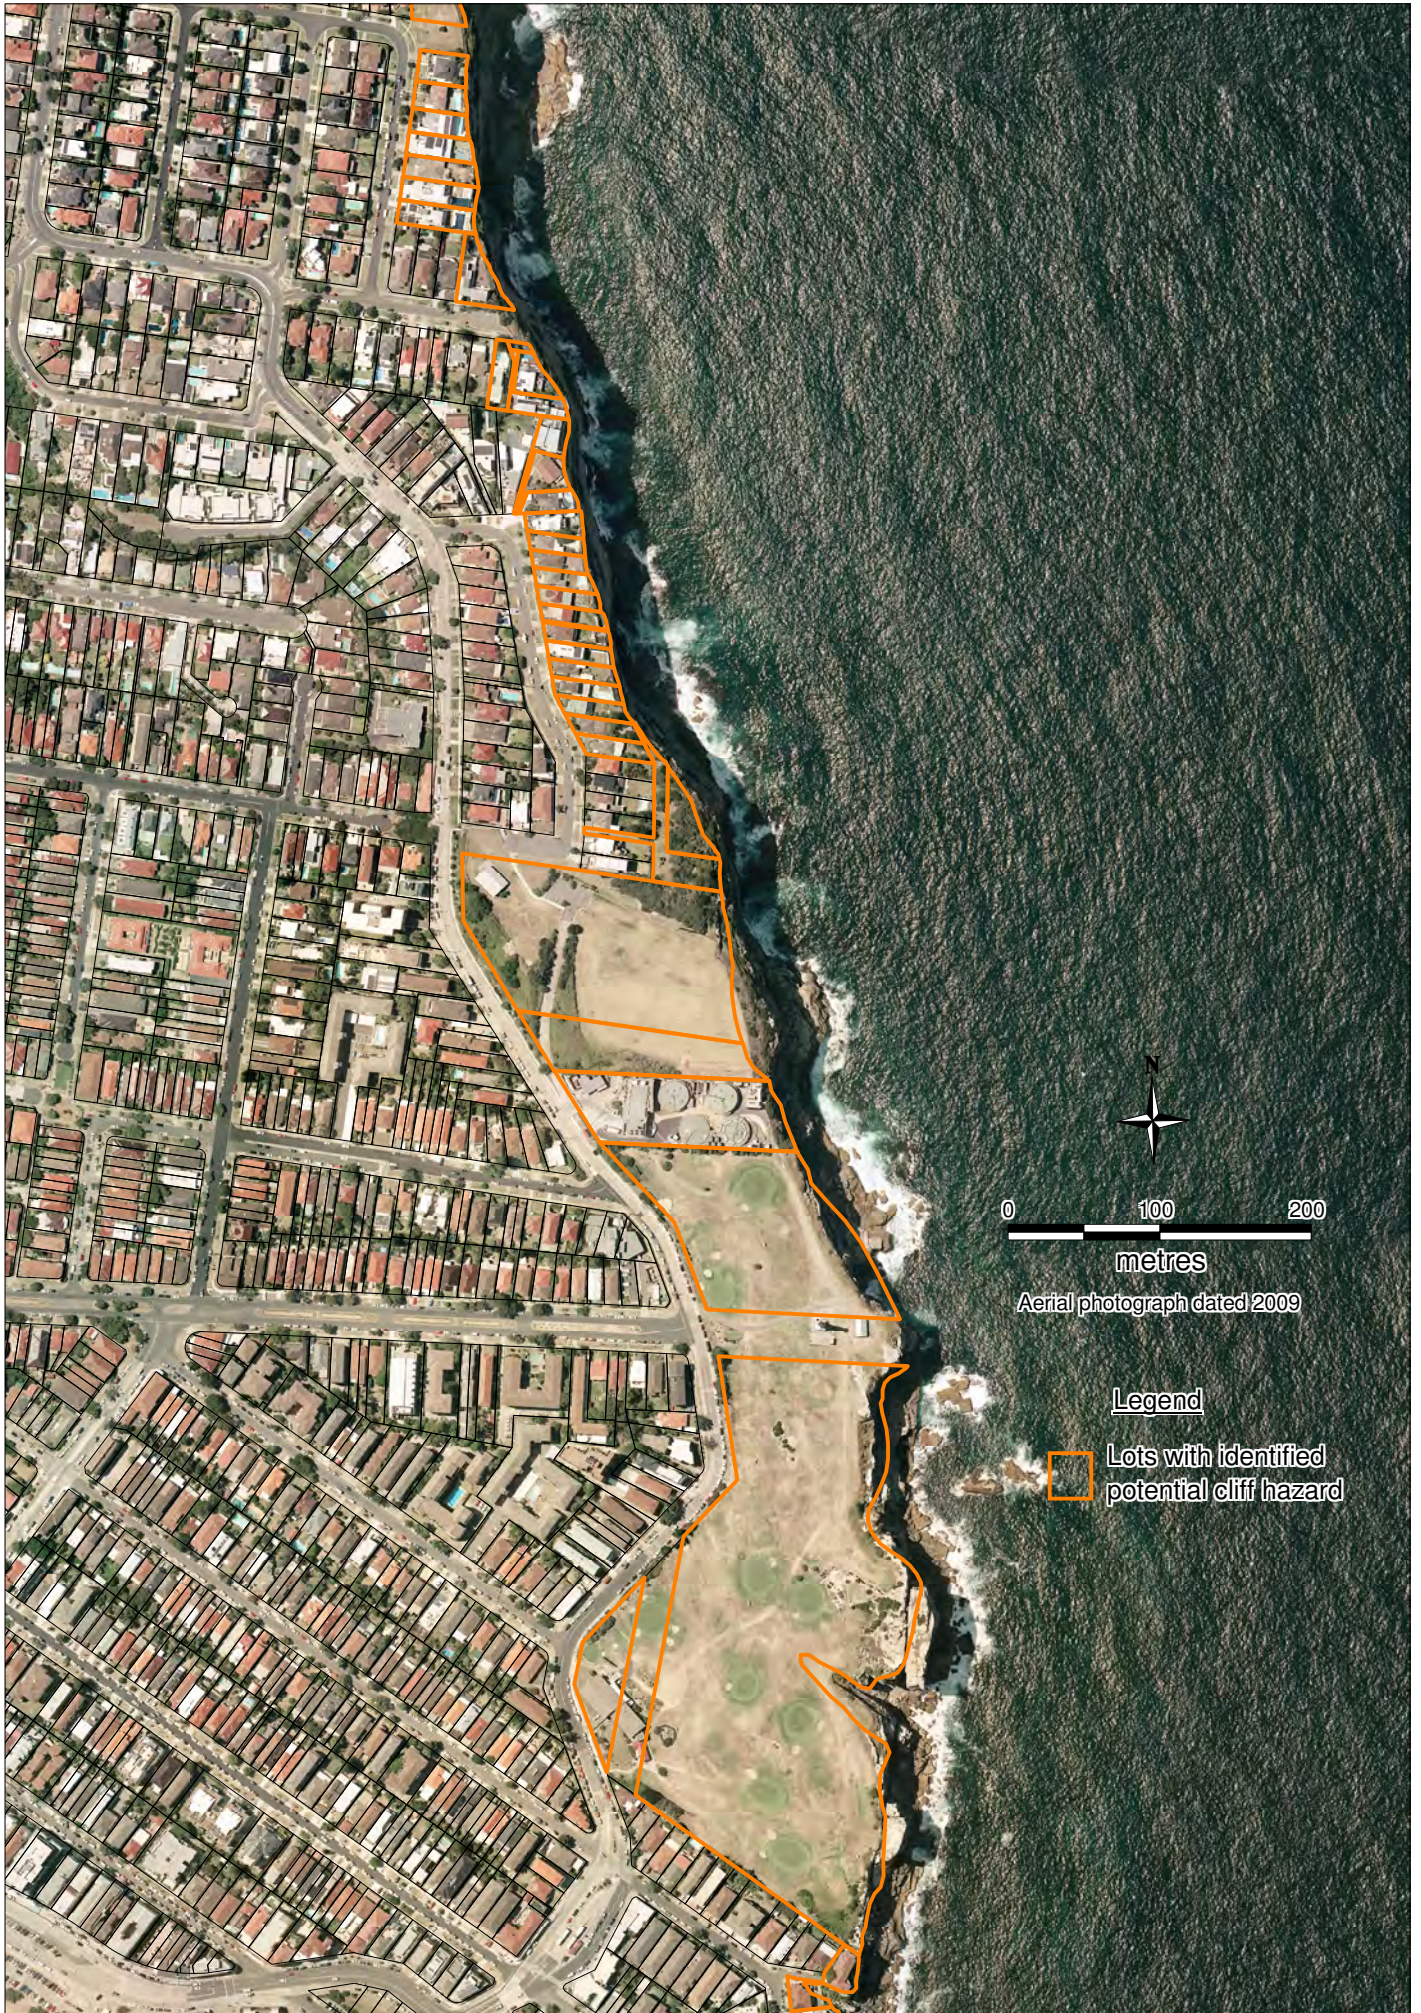
LOTS WITH IDENTIFIED POTENTIAL CLIFF HAZARD (3 OF 6)

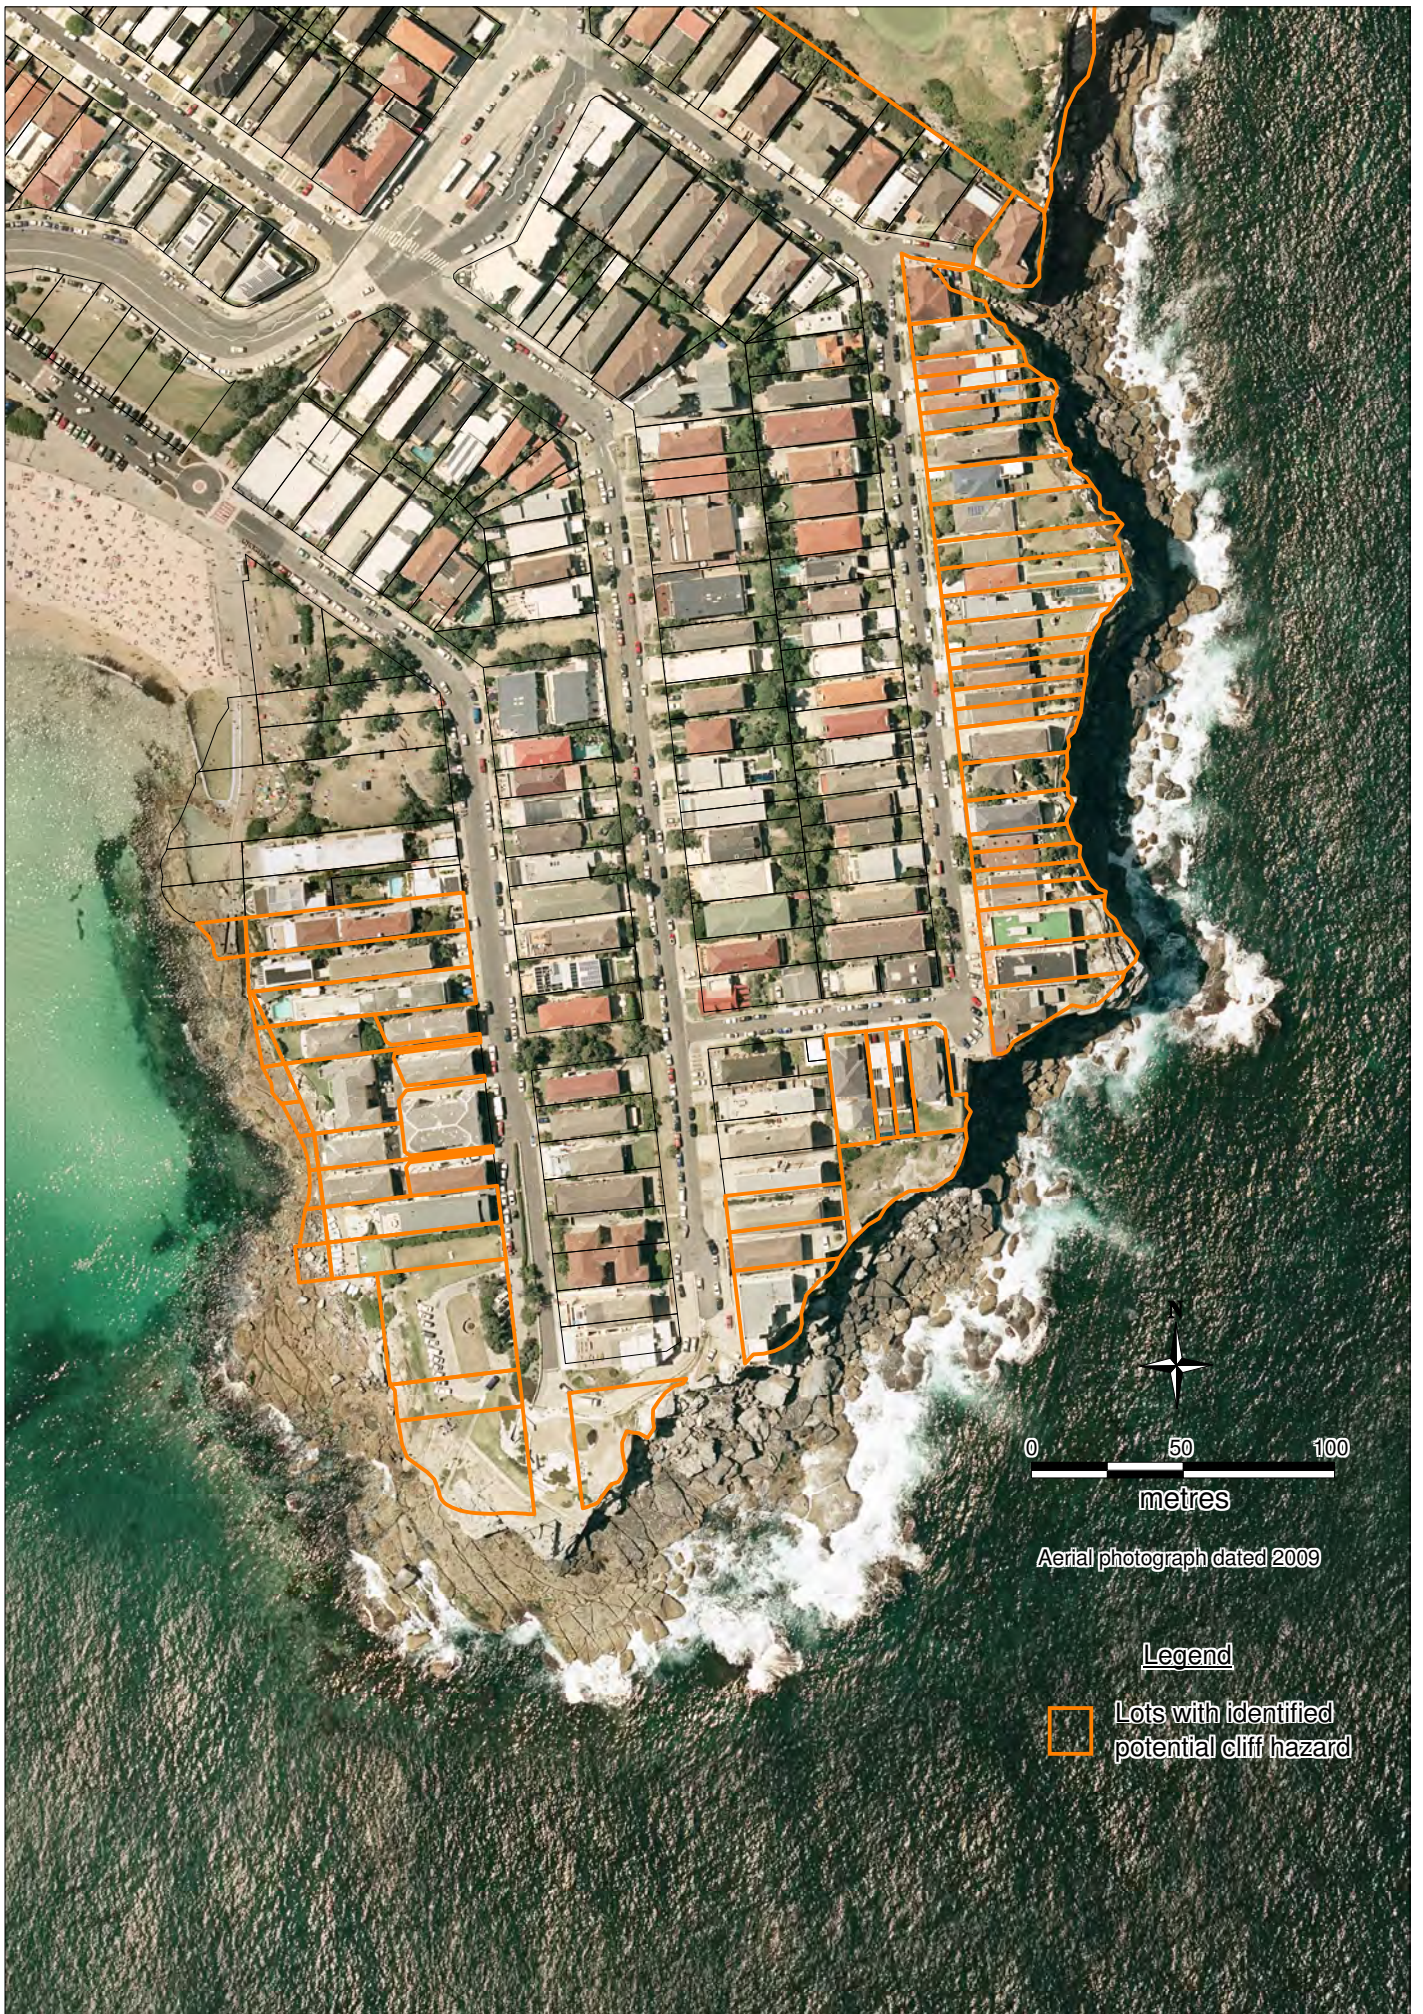
LOTS WITH IDENTIFIED POTENTIAL CLIFF HAZARD (4 OF 6)

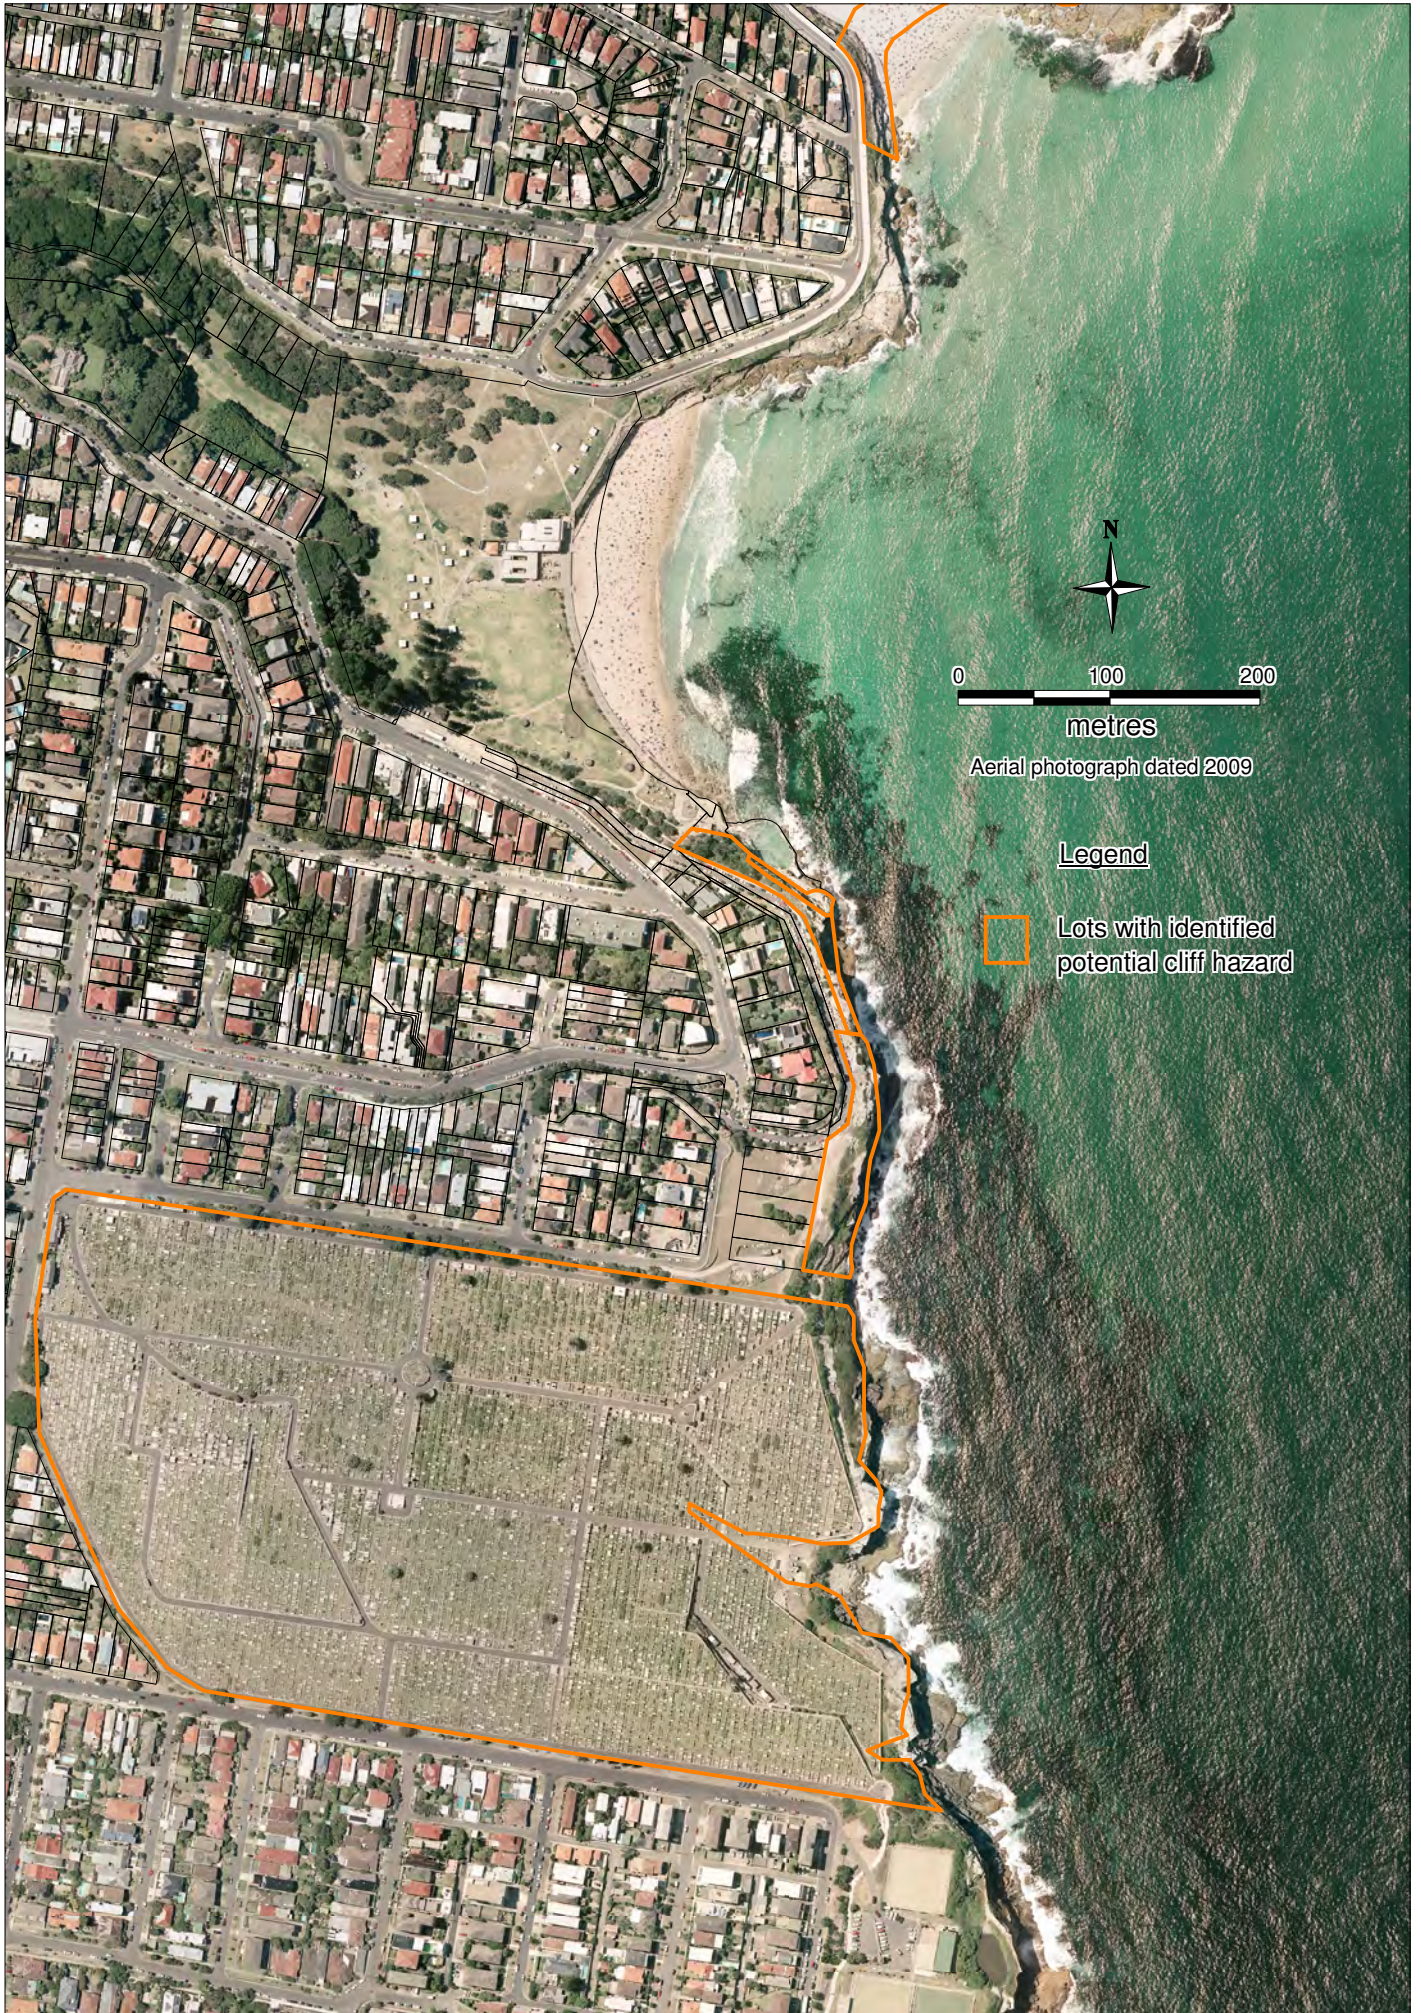
LOTS WITH IDENTIFIED POTENTIAL CLIFF HAZARD (6 OF 6)

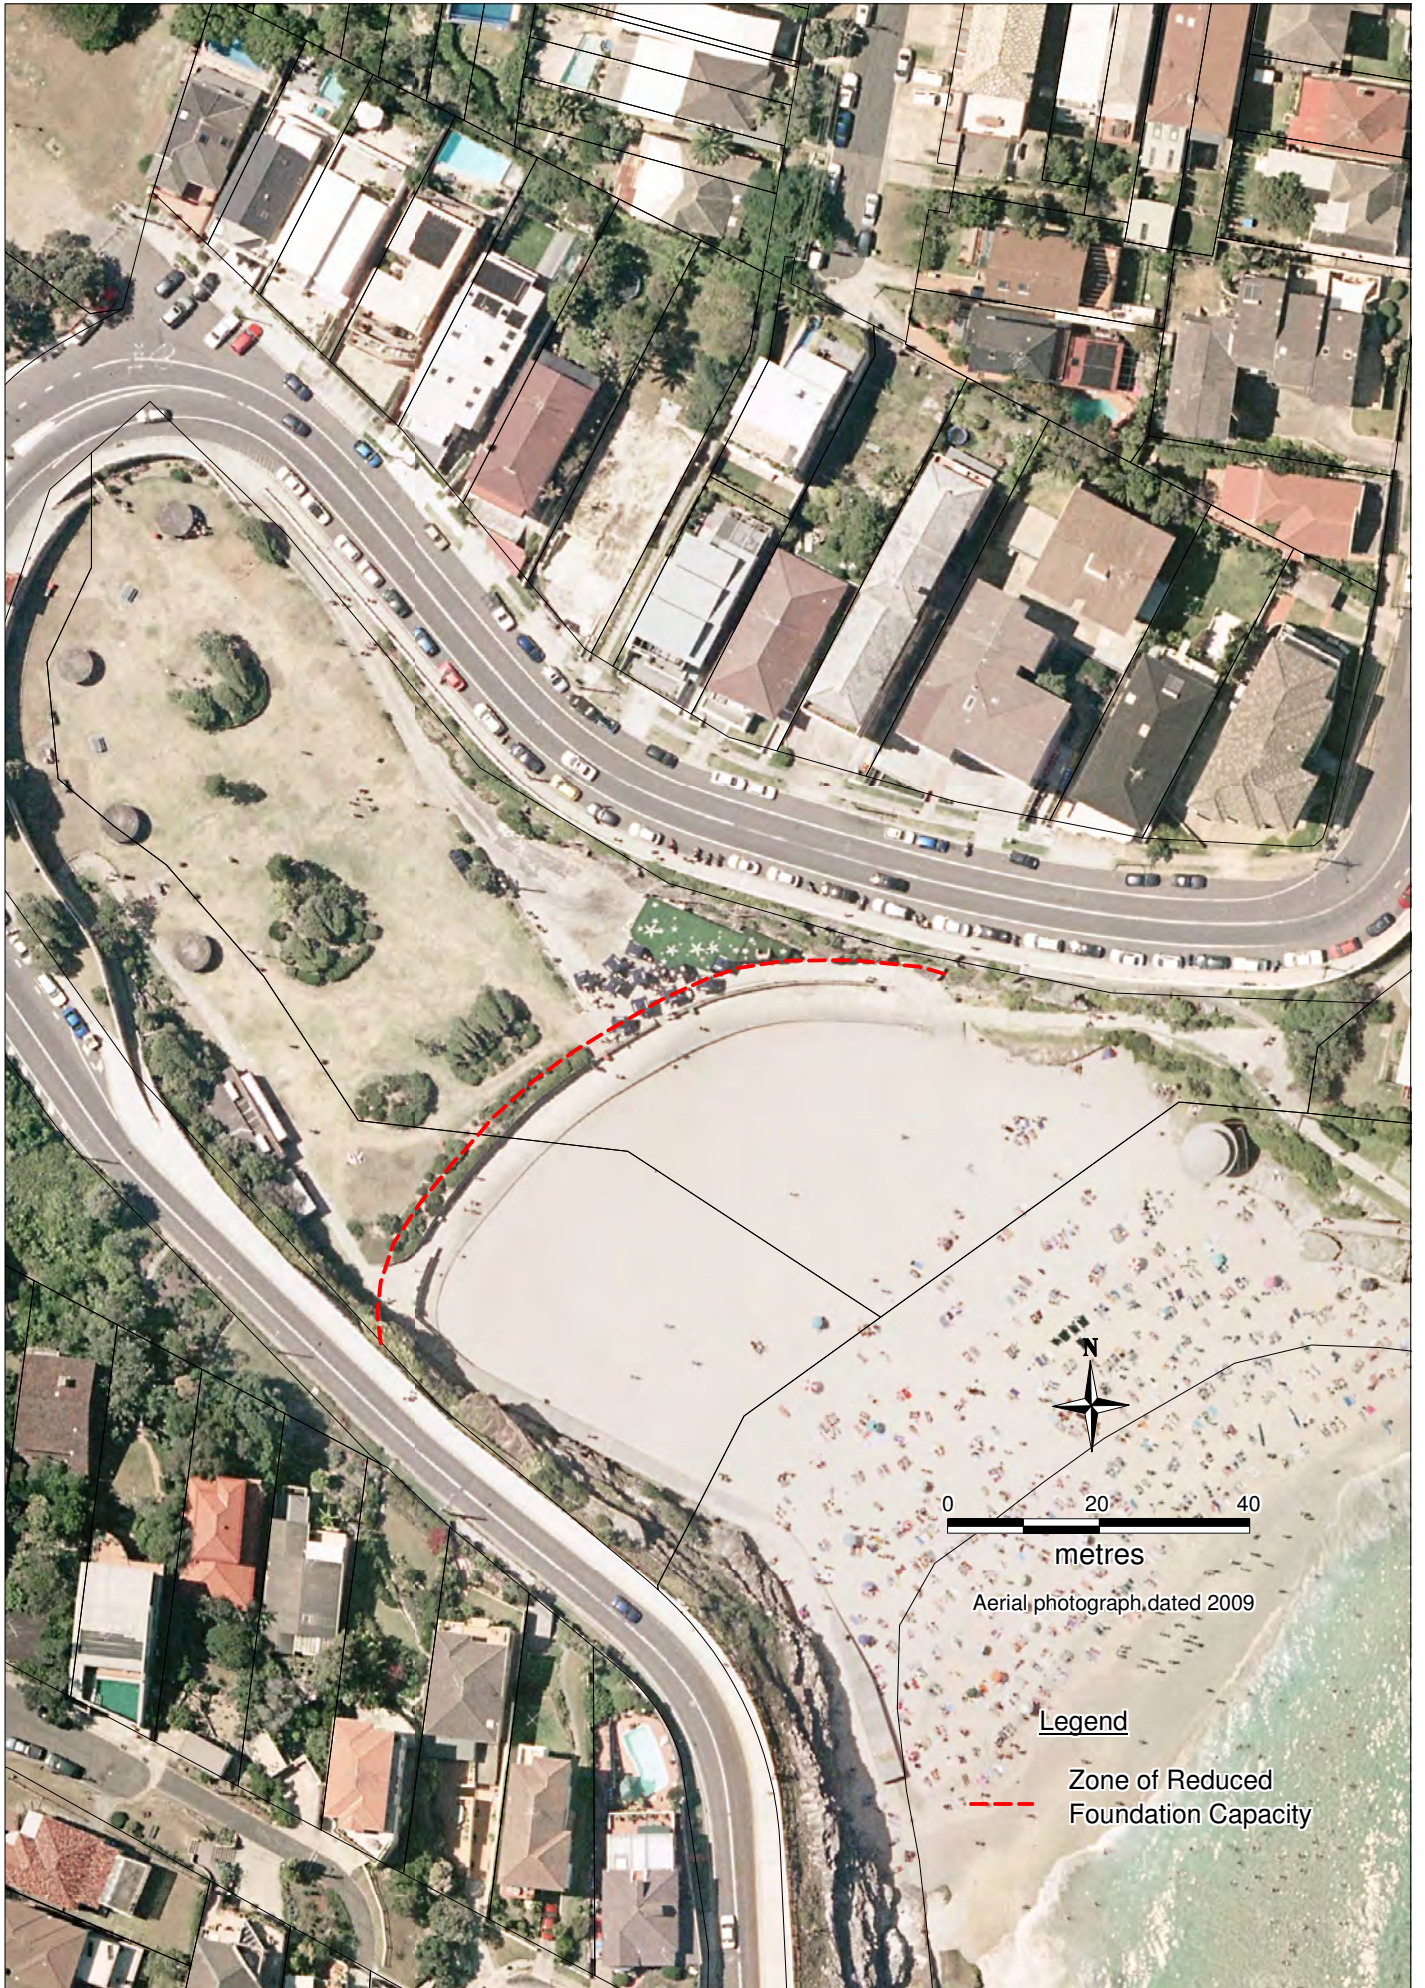
ZONE OF REDUCED FOUNDATION CAPACITY AT TAMARAMA
