WAVERLEY COUNCIL

Coastal Risks and Hazards Vulnerability Study

301015-02526-CS-REP-0001

December 2011

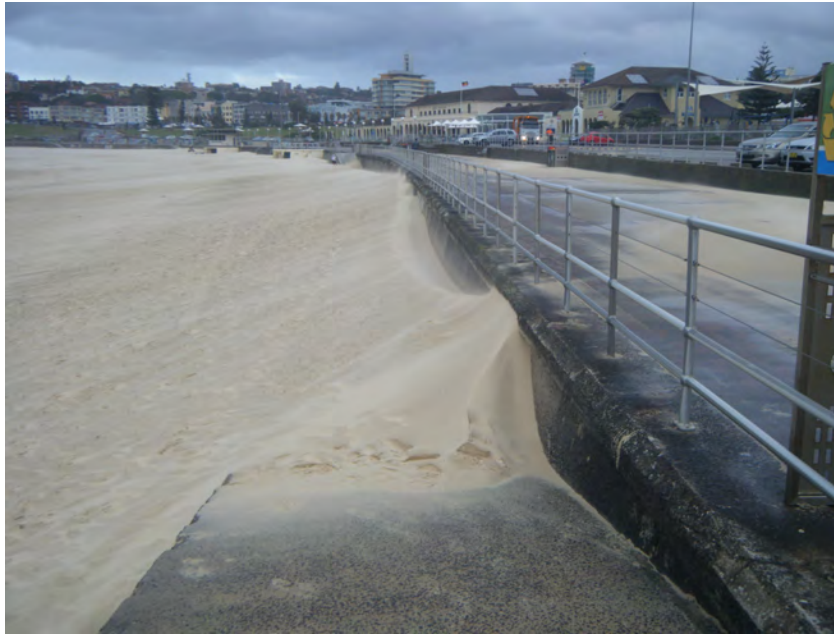
In the past, Bondi Beach in particular was subjected to the removal of beach sand through this process. Old photographs show large bare transgressive sand dunes behind the beach. However, today these have been stabilised by vegetation and development and there are an elevated seawalls landward of the beach along the Waverley beaches. These seawall structures modify the local wind field in such a way so as to cause wind borne sand to drop out of suspension at the sea walls. Therefore, from an overall sediment budget perspective, it is likely that there would be significant sand losses from beaches in the study area due to aeolian processes, notwithstanding that there is some need for sand management practices to deal with sand deposits along and behind the seawalls from time to time. When required, council undertake localised beach scraping, to lower levels of the sand against the seawall, regrading it seaward. In this regard, it is noted that in storms in November 1987 (refer to **Figure 3.3**) and June 2007, windblown sand did move landward into properties and roads, which was probably more a nuisance than a significant sediment loss from the beach. In 2007 the Daily Telegraph reported that “Around 1000 tonnes of sand was scraped up and moved back to Bondi and Tamarama after high winds swept it inland on to parks and roads.” Sand build up against the seawall and sand blowing over the seawall was observed by during a site visit on 15/06/11 (refer **Figure 3.4**).

Figure 3.4 Bondi Beach, 15 June 2011

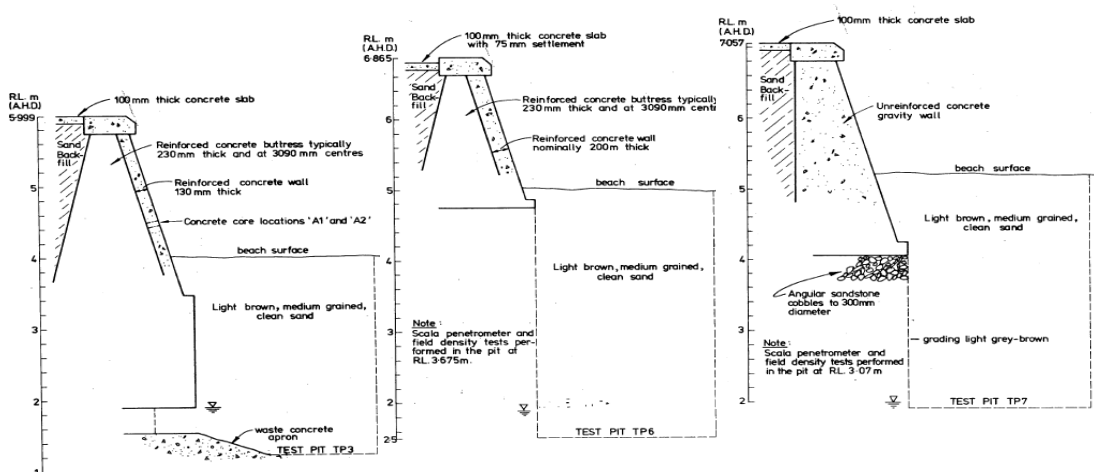
Investigations on the Bondi seawall structure were undertaken by PWD 1988, this included metal detection of reinforcement, 17 concrete core samples (into the face of the seawall), sediment sampling and site excavations (10 boreholes and 15 test pits). These investigations (refer **Figure 3.14**) suggested that the historical design drawings (**Figure 3.13**) provide a reasonable representation of the seawall. A long section of the seawall, showing the varying toe depth along its length, is included as **Figure 3.17**). The seawall details outlined below are taken from the PWD 1988 report.

In 1909 the southern section of the seawall was constructed. This southern section of the seawall (approximately south from the Pavilion) is an unreinforced concrete gravity wall. According to test pits, the toe level of the concrete is around 2 m AHD in some sections and around 4 m AHD in other sections. In some areas bed of sandstone gravel and cobbles up to 300 m thickness was observed beneath the wall. Concrete core tests suggested an average concrete compressive strength of 12 MPa.

The seawall was extended to the northern end of the beach in about 1923. This section of seawall is a reinforced concrete counterfort wall. According to test pits, the toe level of the concrete is around 4 m to 4.7 m AHD for most of its length, with some sections at around 2 m AHD in the north. Investigations suggested that the reinforcement consists of 10 mm diameter bars, with horizontal bar spacing 230 to 300 mm and bar vertical spacing of 400 to 580 mm and cover of 35 to 50 mm. Concrete core tests suggested an average concrete compressive strength of 20 MPa.

Figure 3.14 Cross Sections from test pits (Source: PWD 1988)

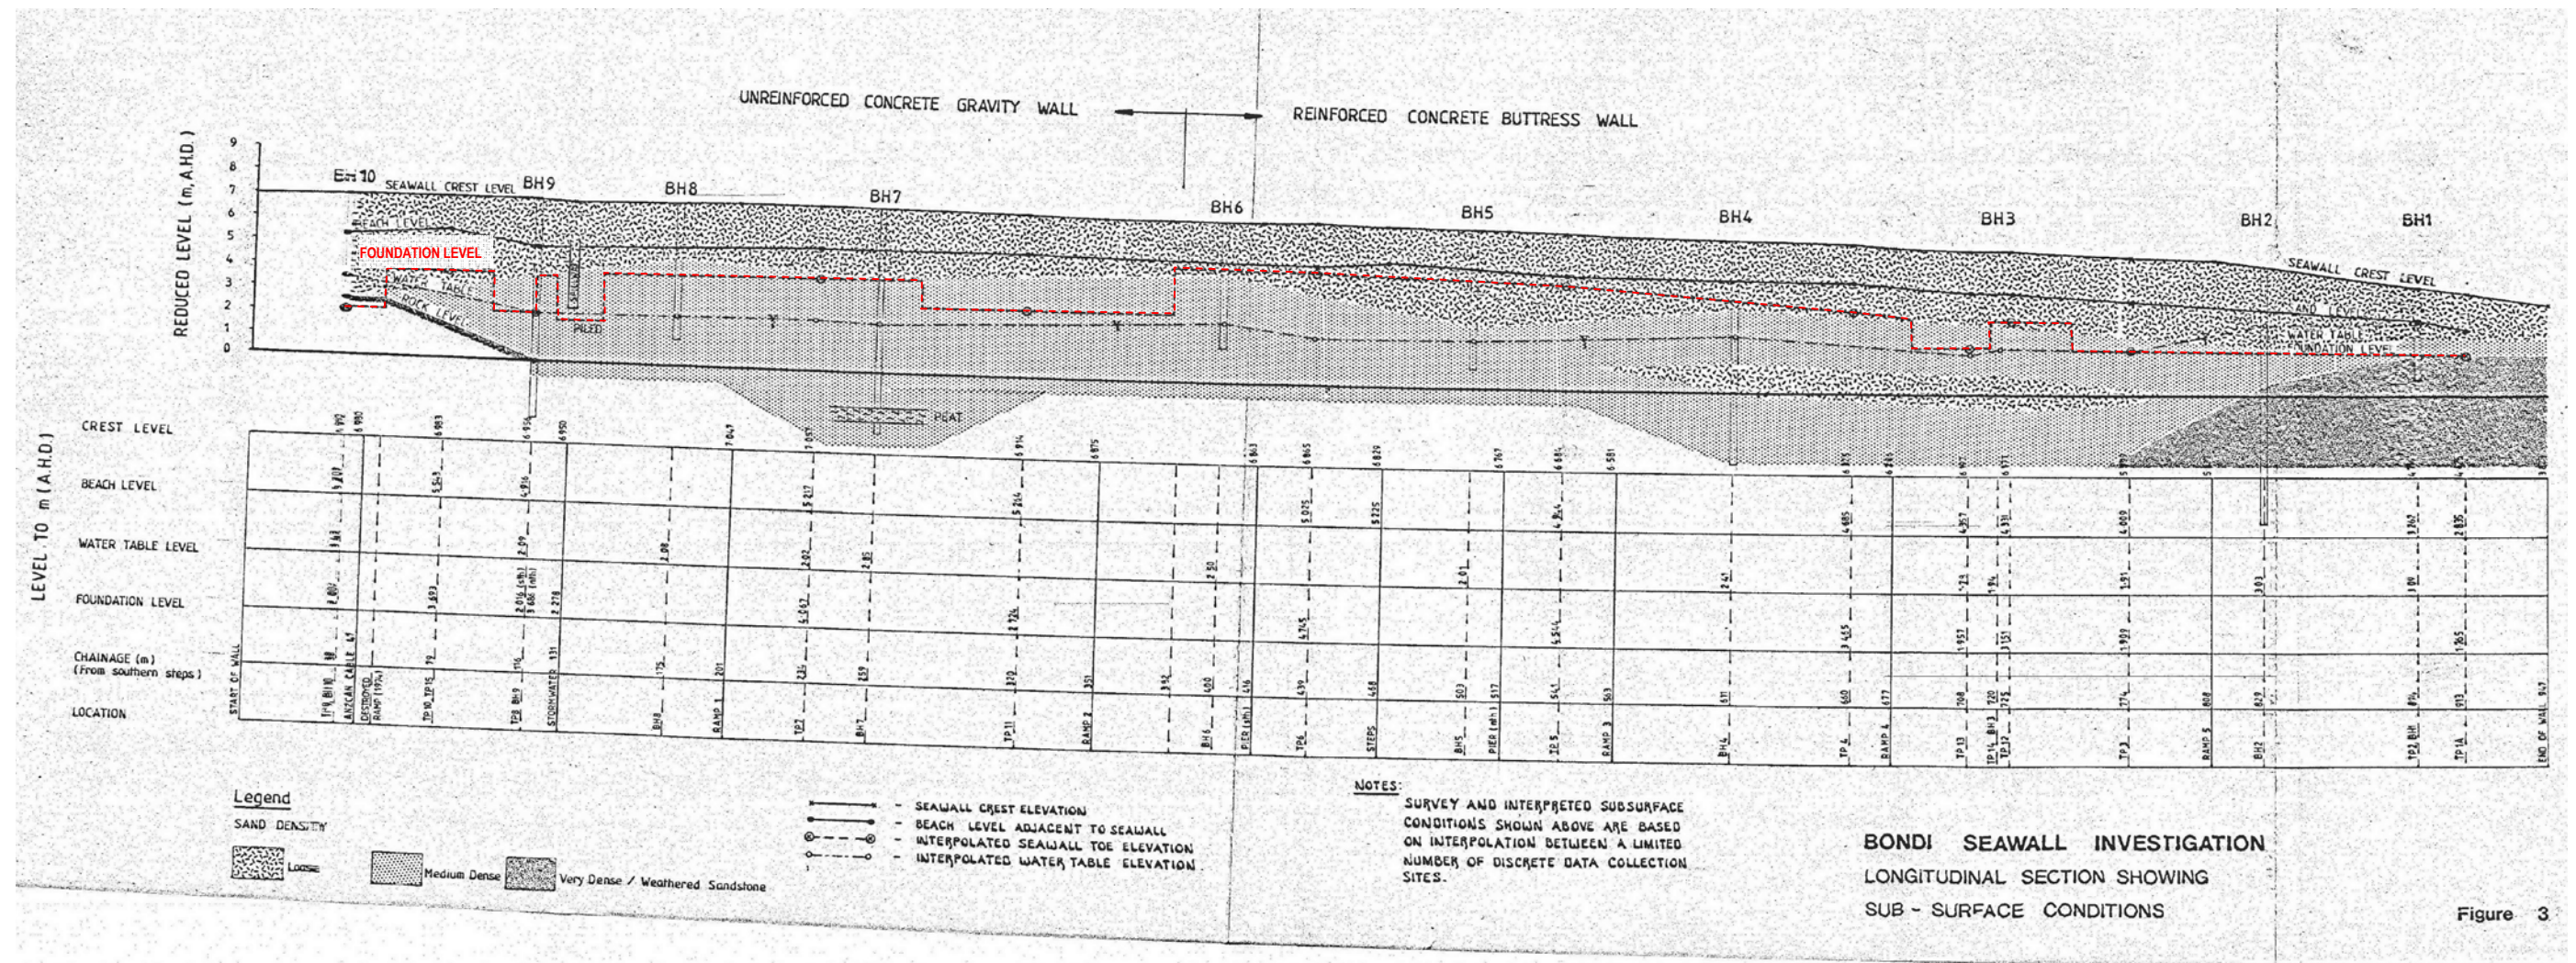
Figure 3.17 Long Section Of Bondi Seawall and Foundations (Source: PWD 1988)

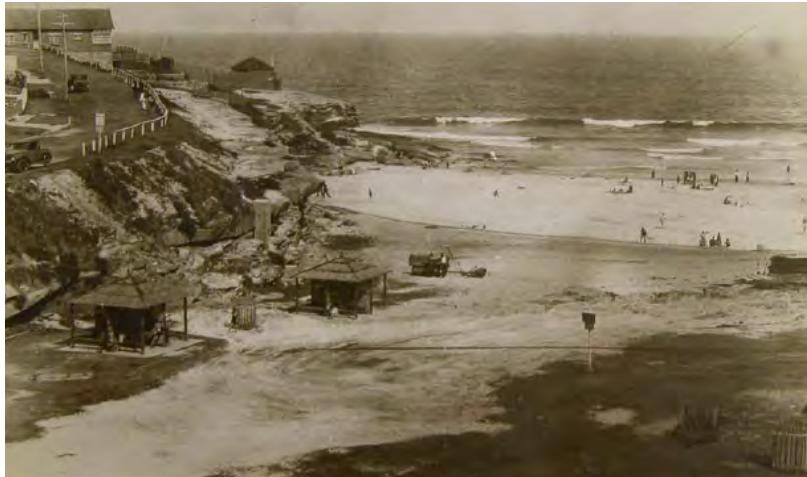
The first seawalls were built at Tamarama by Anderson for Wonderland City in 1906/7, but much of these were in ruins by the 1920's. Plans were prepared in 1924, for new works to the Beach (refer **Figure 3.18**) including stormwater and seawall works. The plan shows existing sections of sea wall and a proposed new section of wall linking up with the existing walls. It would seem that the new sea wall was built shortly afterwards, along with several picnic huts (first proposed in 1923), as **Figure 3.19** shows. No information on the cross section design of Tamarama seawall has been able to be sourced.

Figure 3.19 Tamarama, 1927. A seawall can be seen. (Source: Waverley Library)

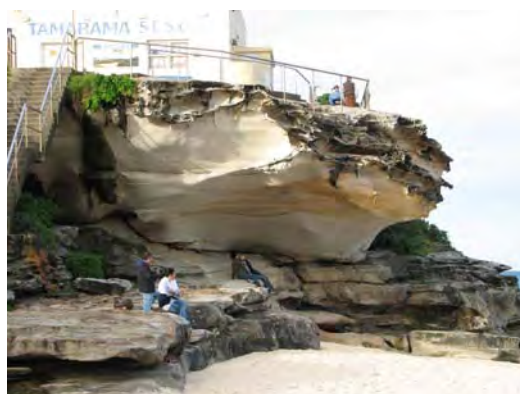
In addition, similar differential weathering and erosion (by wave and wind action) of relatively weak sub-horizontal XWS, shale bands and clay bands over the cliff faces has led to the formation of the numerous cliff top overhang features identified along the study area and undercut features at the base and over the cliff face.

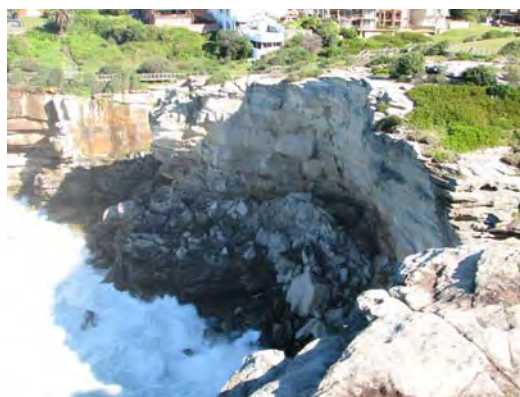
Collapse of these overhangs has also occurred in a similar manner as described above. The rock fall at Diamond Bay is believed to be due to such a mechanism although the form of the rock fall appears to have been controlled at least in part by the relatively weaker mass strength of the rock rather than strictly controlled by the orthogonal joint sets. This may be due to localised alteration of the rock mass due to the elevated heat associated with the intrusion of the igneous dykes to the north and south of the rock fall. The alteration appears to have weakened the overall strength of the rock mass in this area.

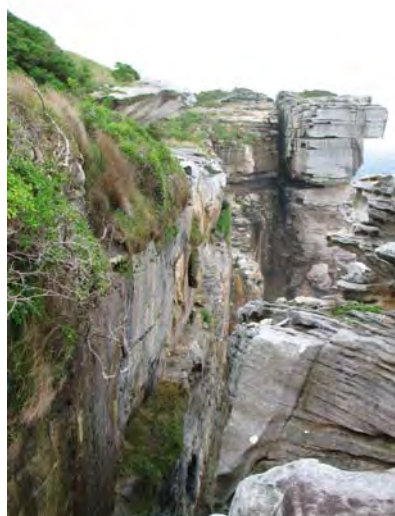
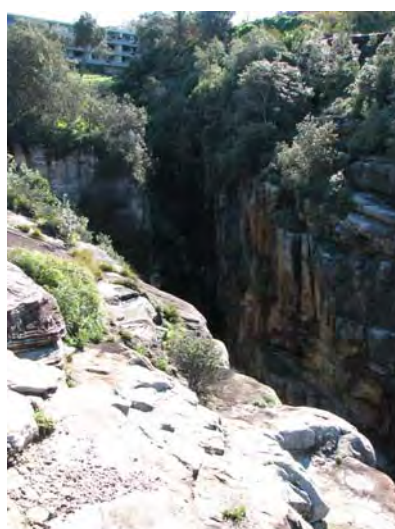
The igneous dykes and shear zones typically comprise extremely weathered/residual soil materials which are often fractured. These relatively weaker sub-vertical features are also affected by differential weathering and erosion (by wave and wind action) and have resulted in the formation of the cliff line gullies described in Section 3, above.

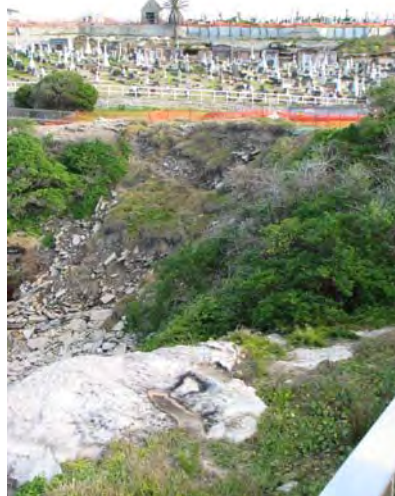
Instability of soil slopes over sections of the cliff faces was also identified at selected locations. Instability of such slopes is typically governed by one or more of the following factors; over-steep batter slopes, elevated water pressures within the soils associated with ineffective drainage systems and/or surface water run-off and erosion of the toe of the slopes by wave action.

The most dramatic example of a number of these factors affecting one slope was the fill batter slope infill of the gully feature within Waverley Cemetery.

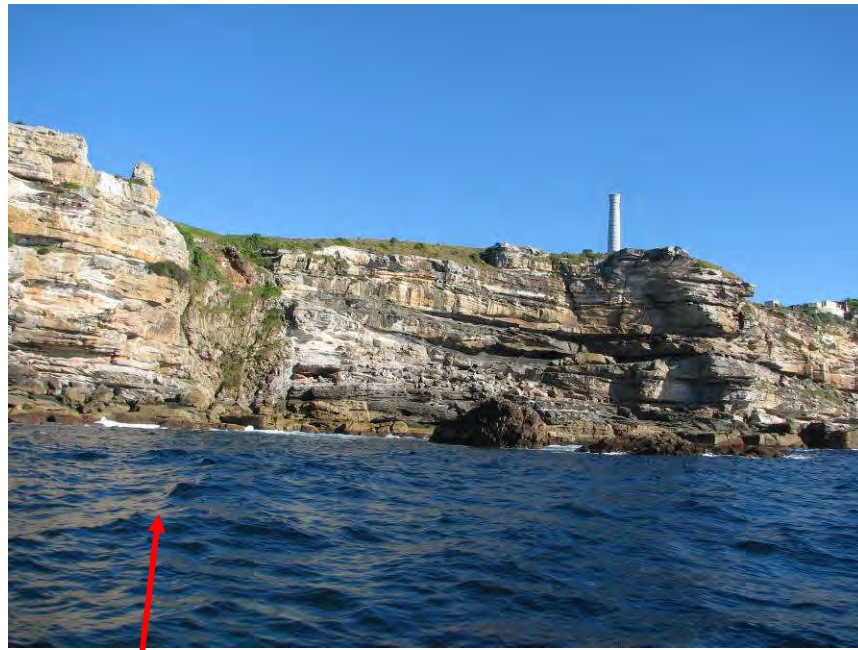
Trace of igneous dyke

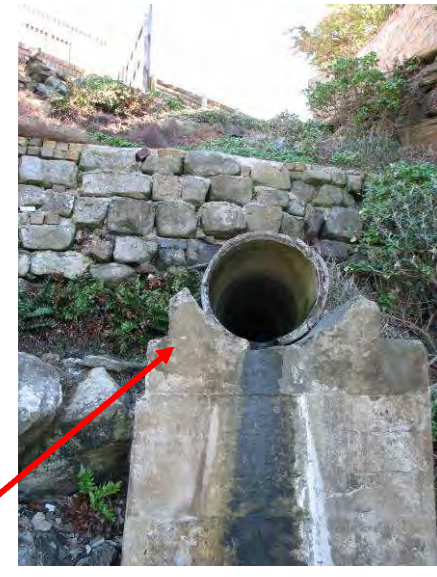
Igneous dyke eroded to form gully

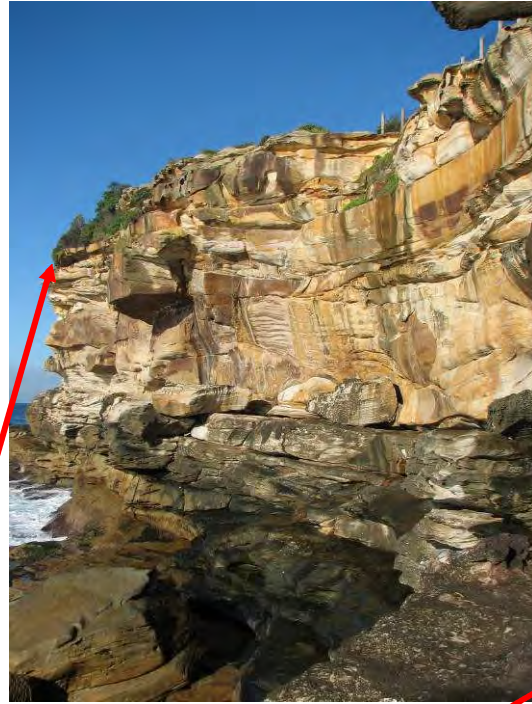
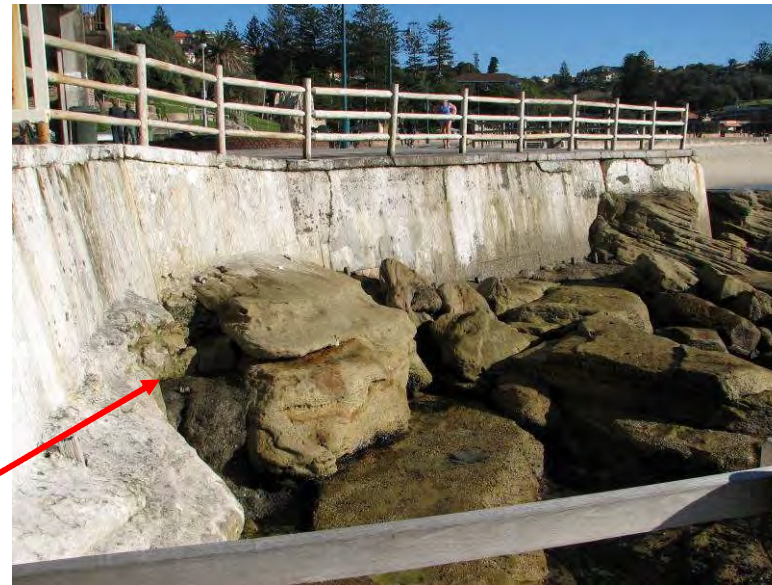
Roof of stormwater box culvert

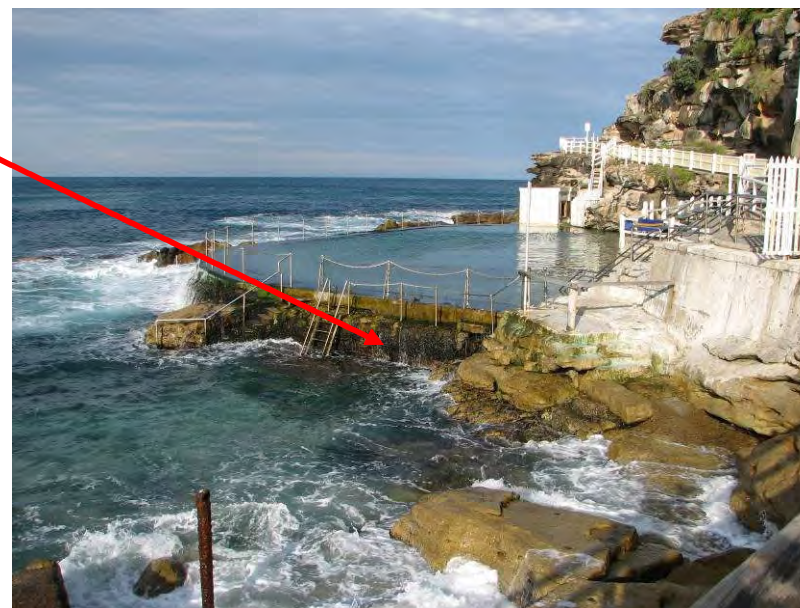
Bronte rock baths

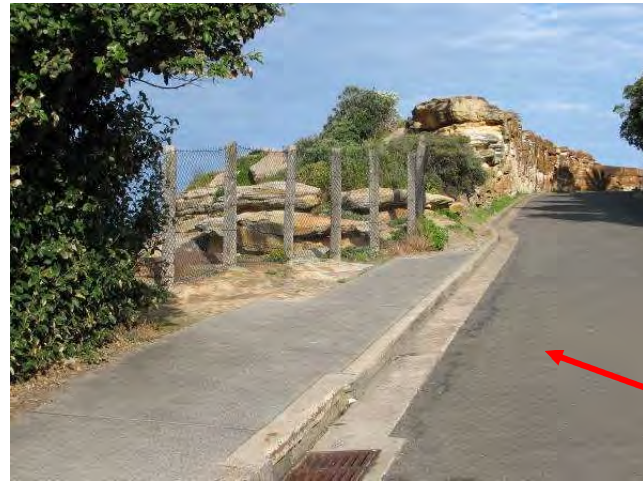
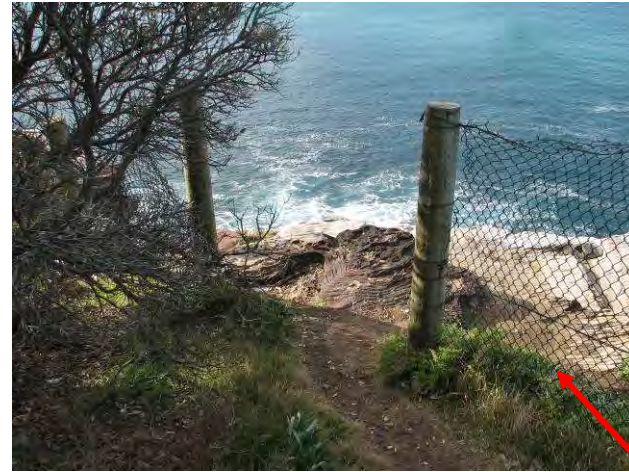
Damaged fence on Calga Place

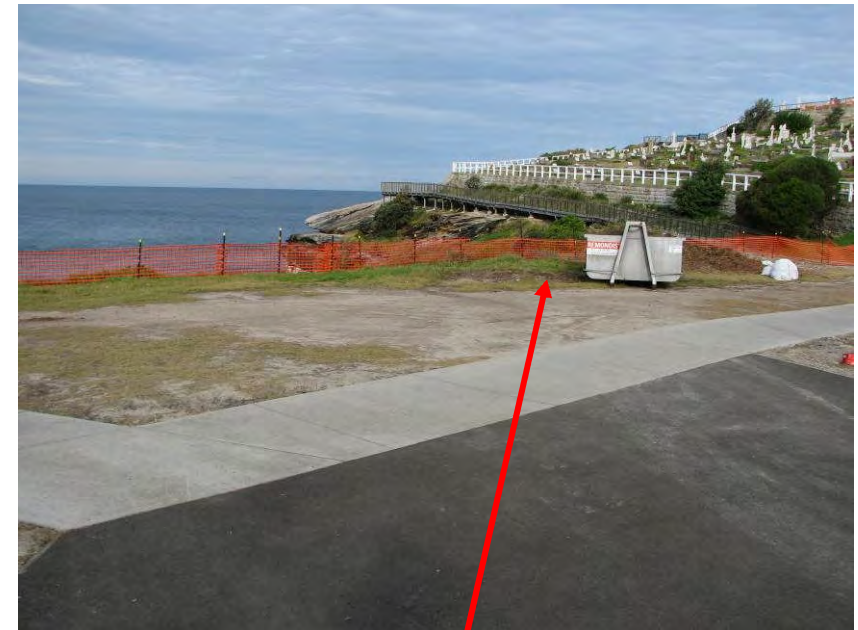
Crest area of gully feature

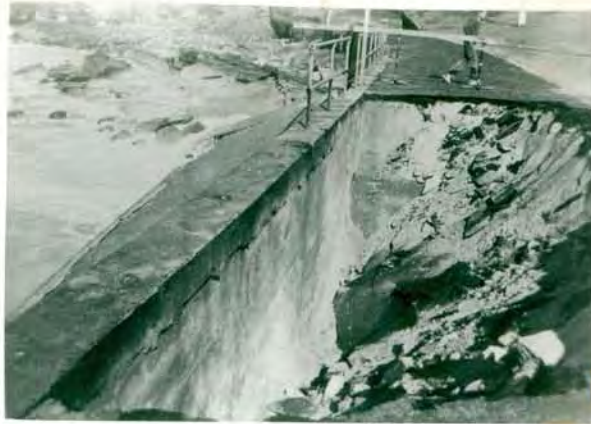
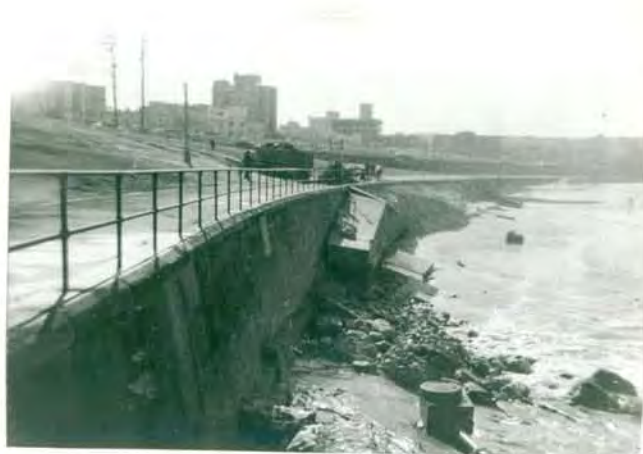
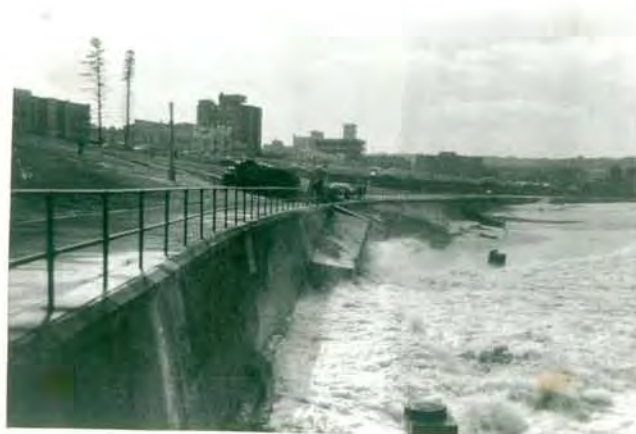
PHOTOS TAKEN AT THE SOUTHERN END OF BONDI BEACH
12 NOON THURSDAY . 13th JUNE 1974

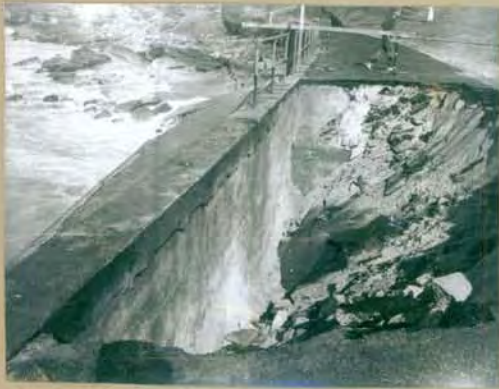
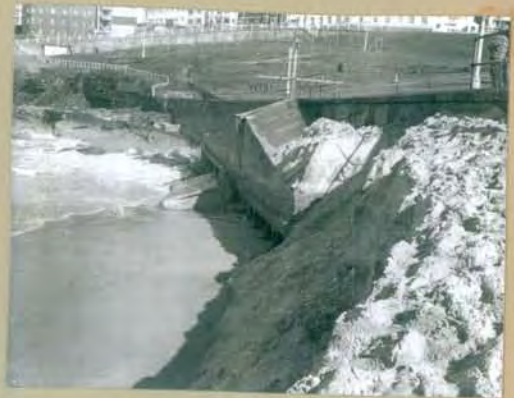
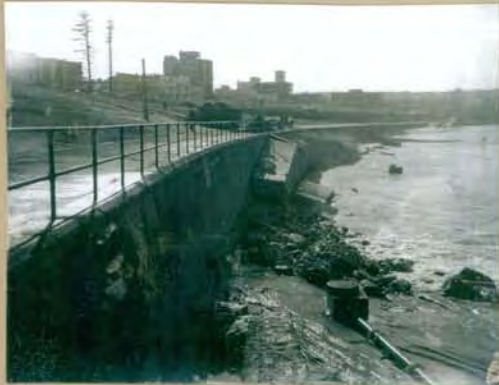
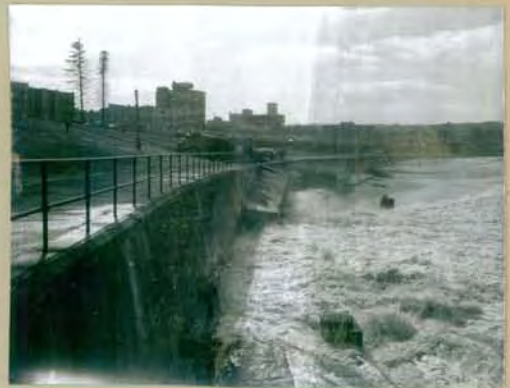
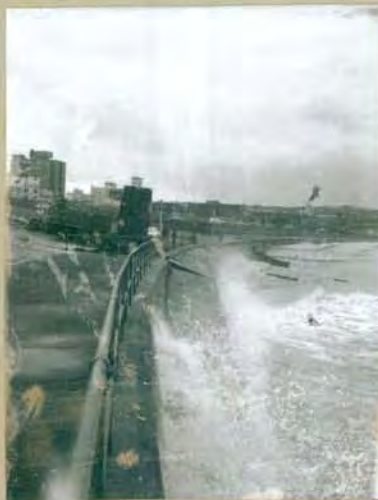
PHOTOS TAKEN AT THE SOUTHERN END OF BONDI BEACH

12 NOON - THURSDAY, 13th JUNE 1974.

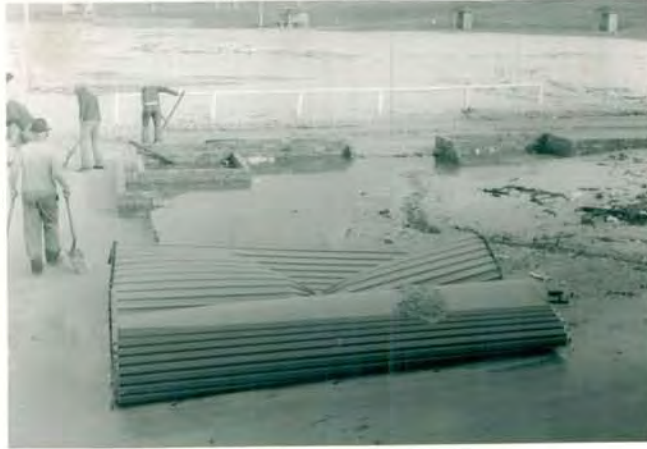
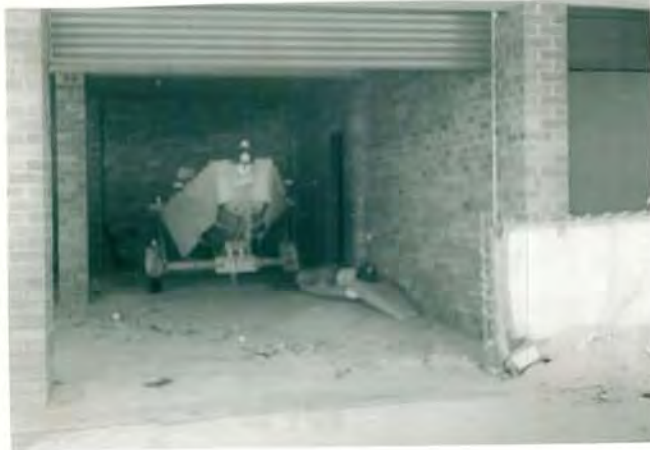
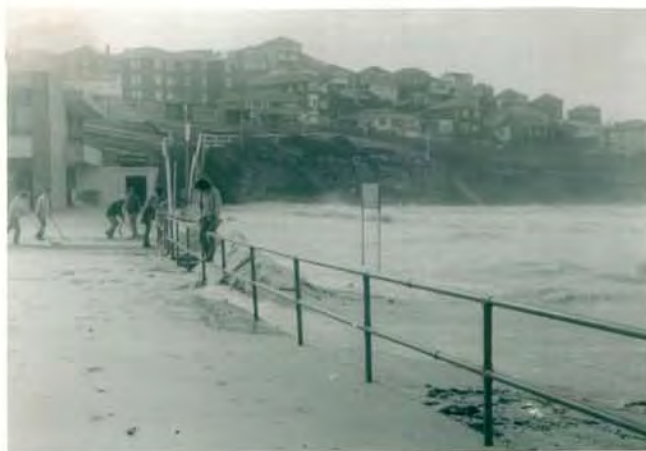
BRONTE BEACH STORM DAMAGE (28-5-74)
PHOTO'S D.V. ABBOTT 27-5-74

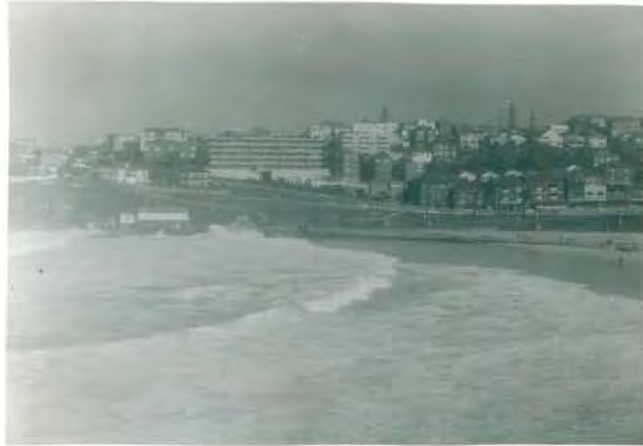
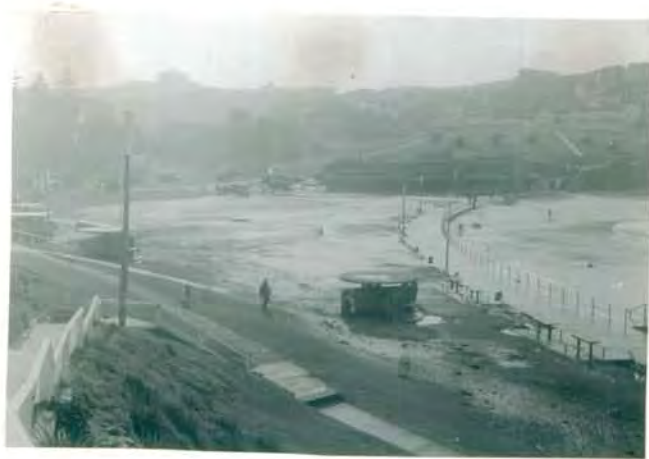
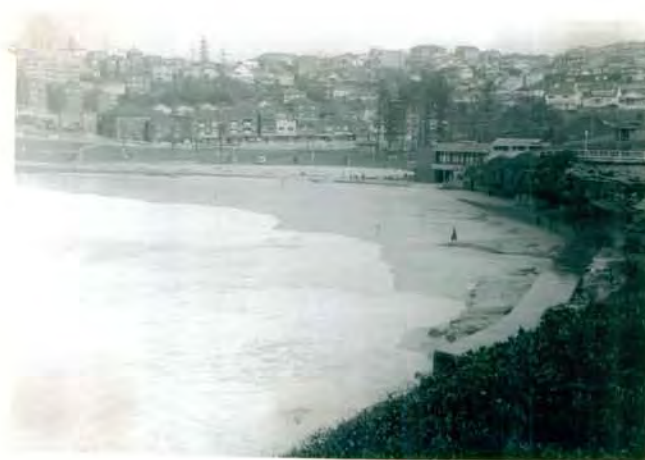
BRONTE BEACH STORM DAMAGE (26.5.74)
PHOTO'S D.V.ABBOTT 27.5.74

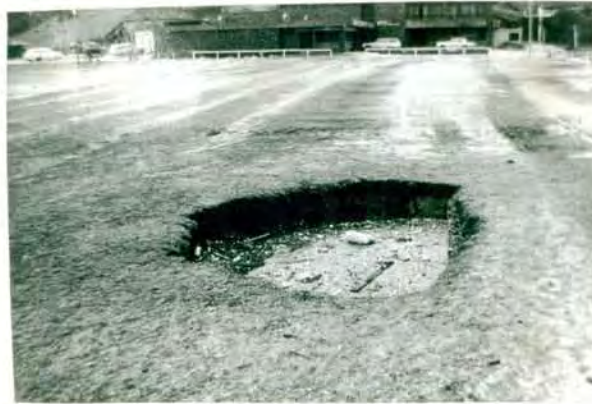
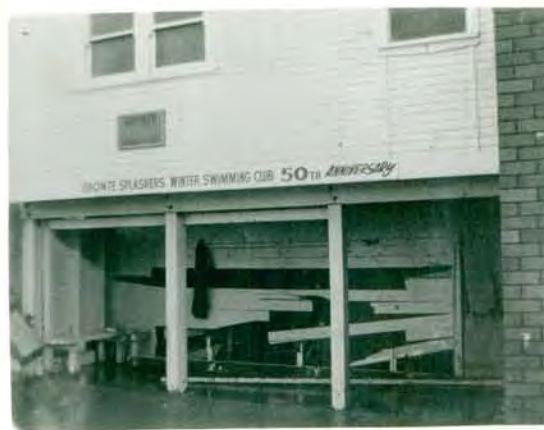
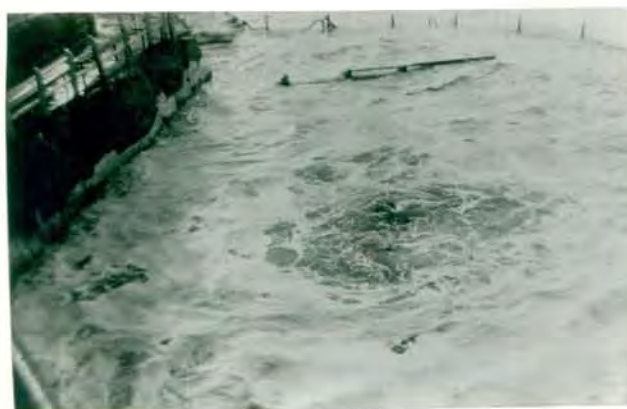
BRONTE BEACH STORM DAMAGE

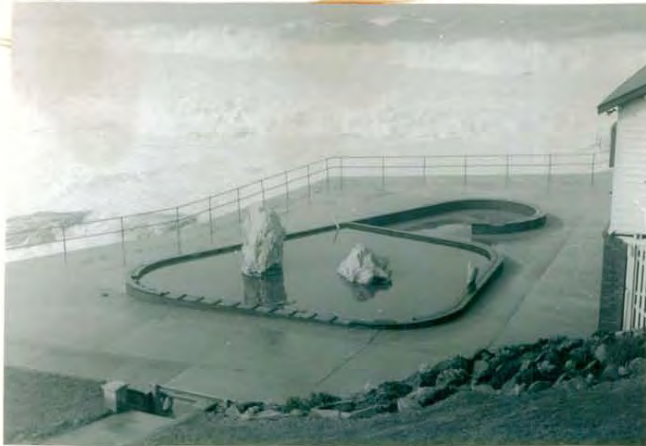
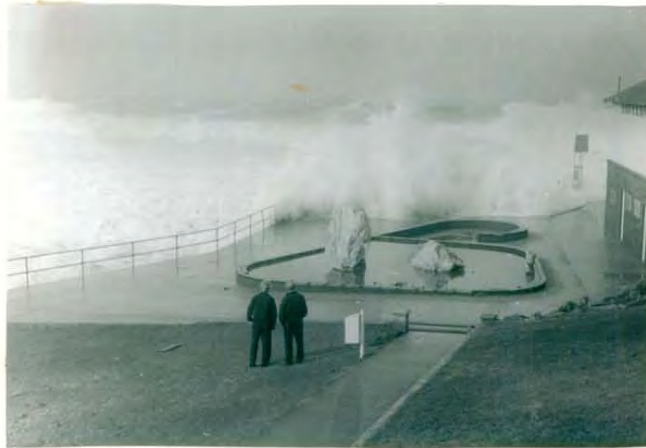
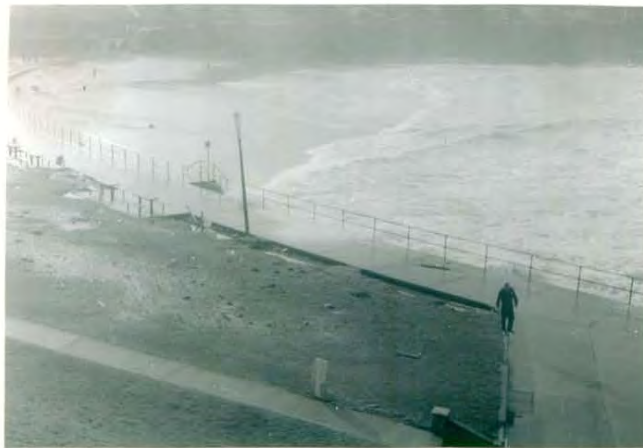
BRONTE BEACH STORM DAMAGE (26-5-74)
PHOTOS D.V.ABBOTT 27-5-74

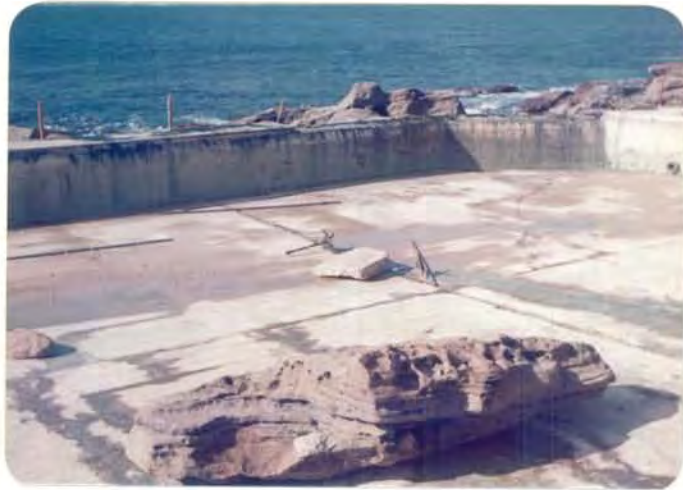
ROCK DEPOSITED IN BRONTE BATHS
26.6.74

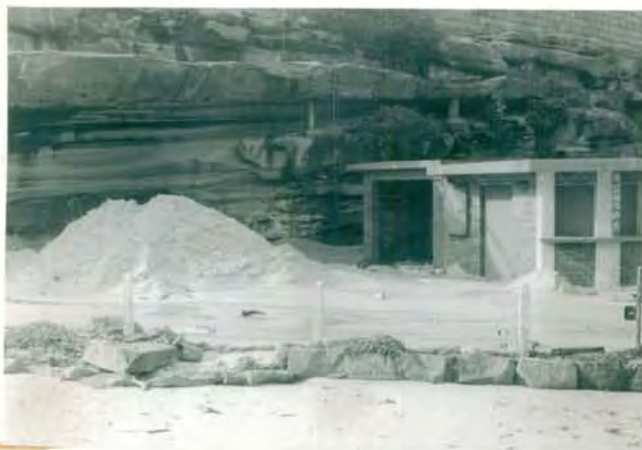
TAMARAMA BEACH

STORM DAMAGE
26-5-74

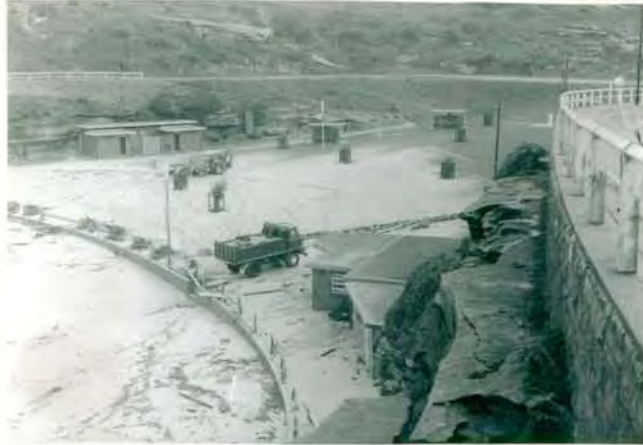
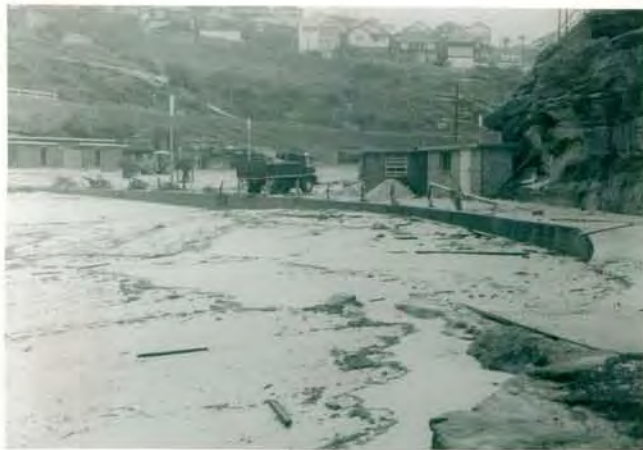
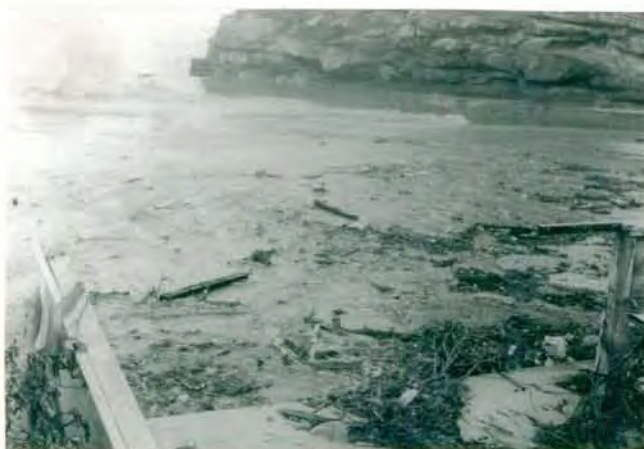
TAMARAMA BEACH STORM DAMAGE (26.5.74)
PHOTO'S D.V. ABBOTT 27.5.74

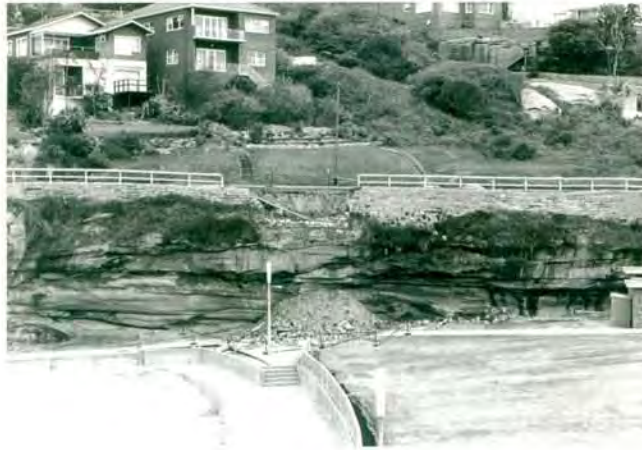
TAMARAMA PARK STORM DAMAGE to
RETAINING WALL

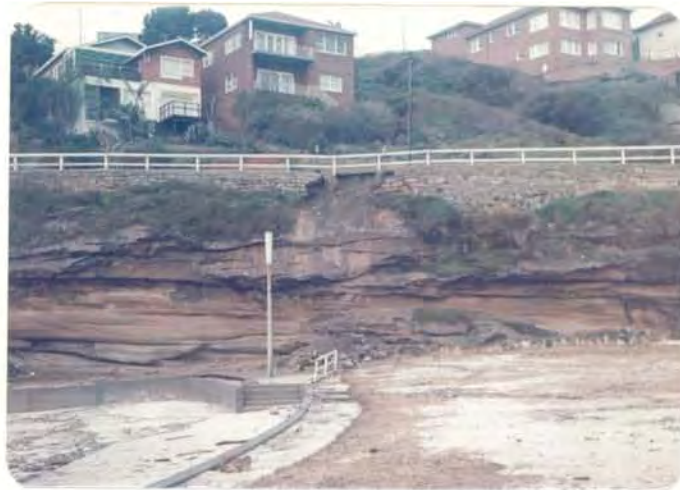
TAMARAMA BEACH STORM DAMAGE 26-8-74

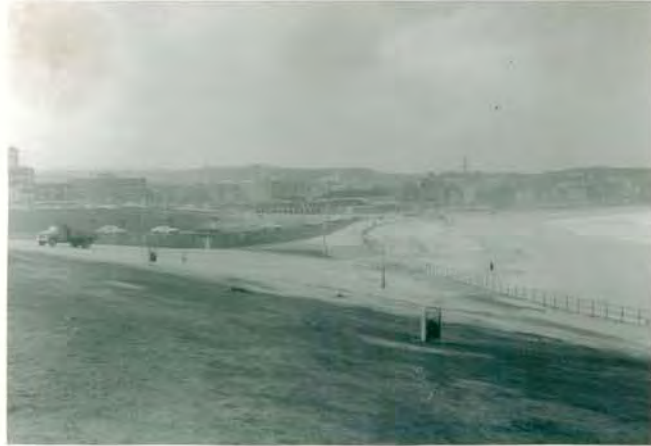
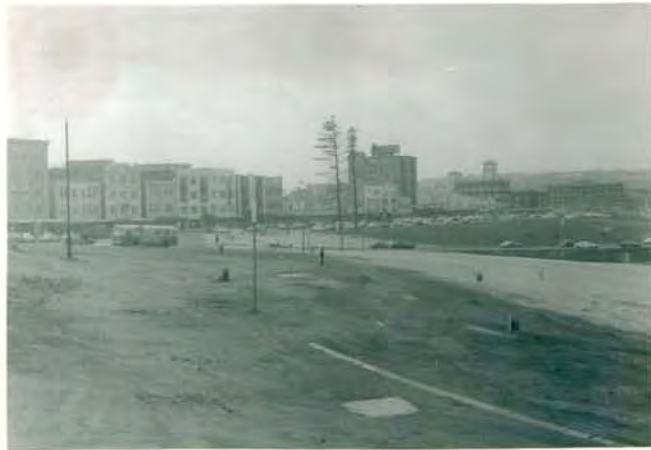
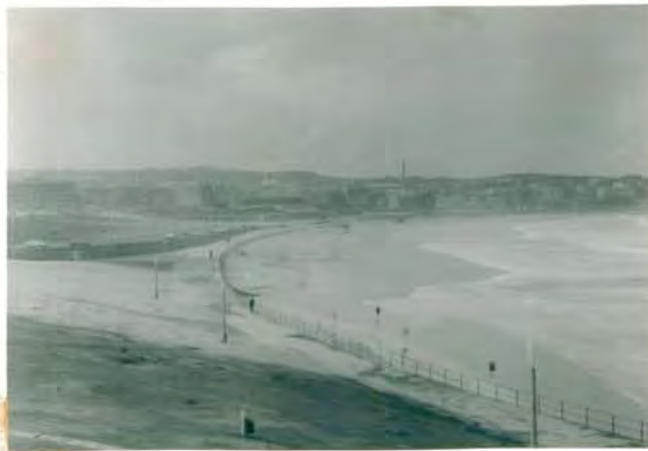
BONDI BEACH STORM DAMAGE
PHOTOS TAKEN D.V. ABBOTT 27.5.74

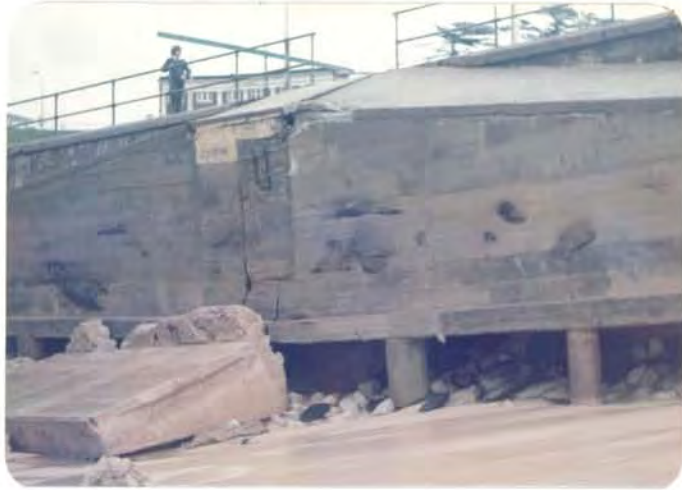
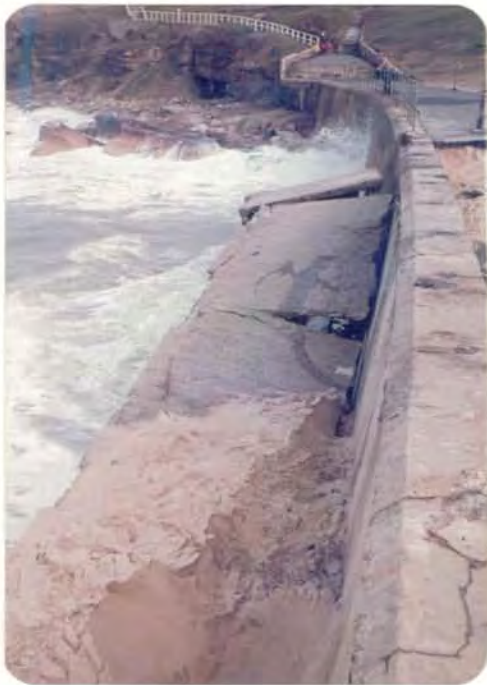
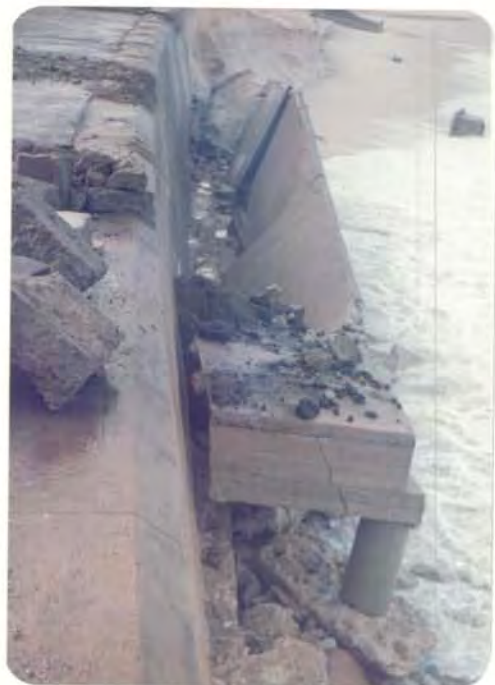
BONDI BEACH STORM DAMAGE 13th JUNE 1974

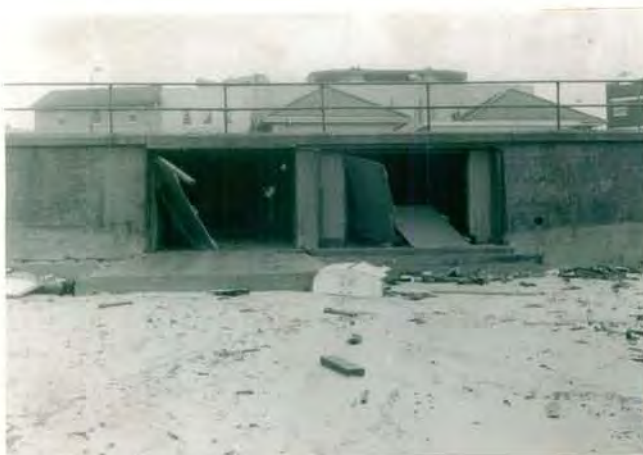
NTH BONDI BEACH

STORM DAMAGE

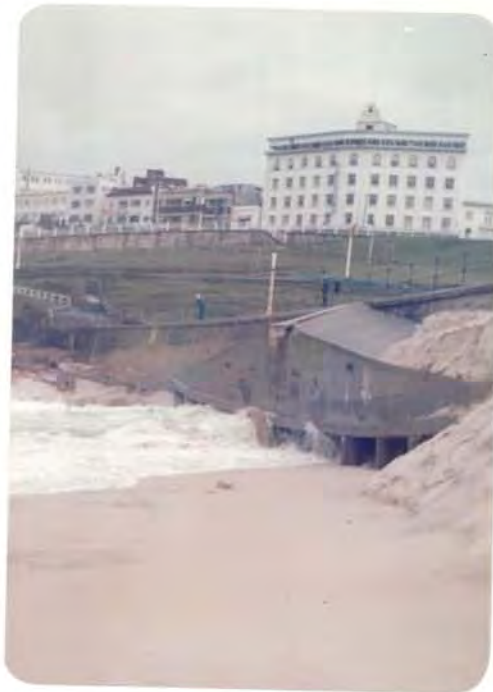
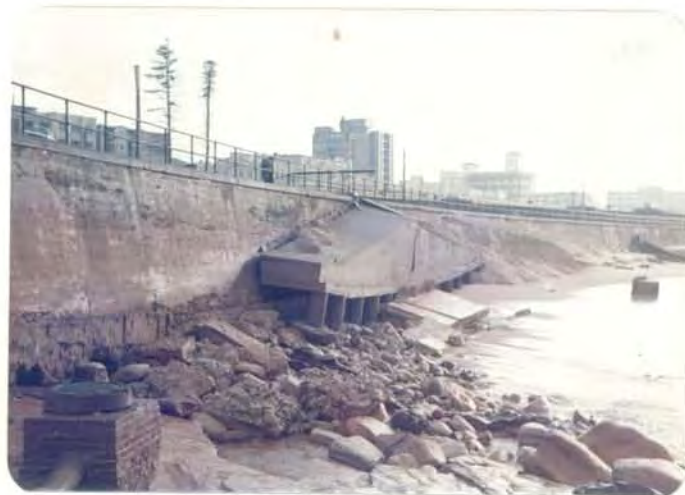
BONDI BEACH STORM DAMAGE 13th JUNE 1974
PHOTOS TAKEN M DOBSON

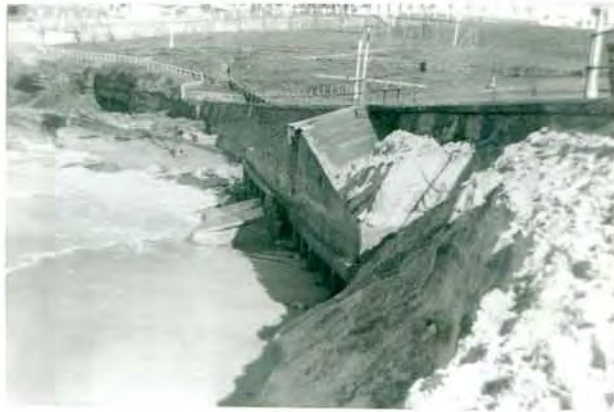
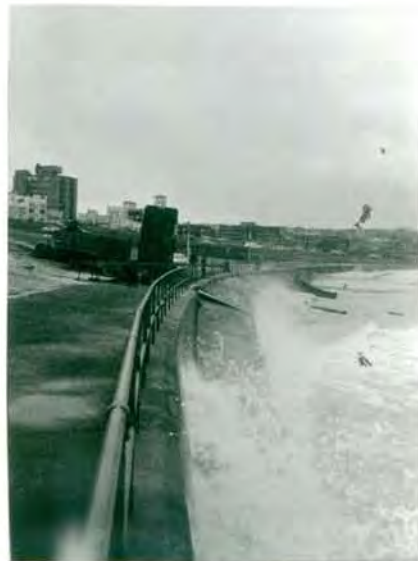
PHOTOS TAKEN AT THE SOUTHERN END OF BONDI BEACH

12 NOON THURSDAY 13th JUNE 1974
