WAVERLEY COUNCIL

Coastal Risks and Hazards Vulnerability Study

301015-02526-CS-REP-0001

December 2011

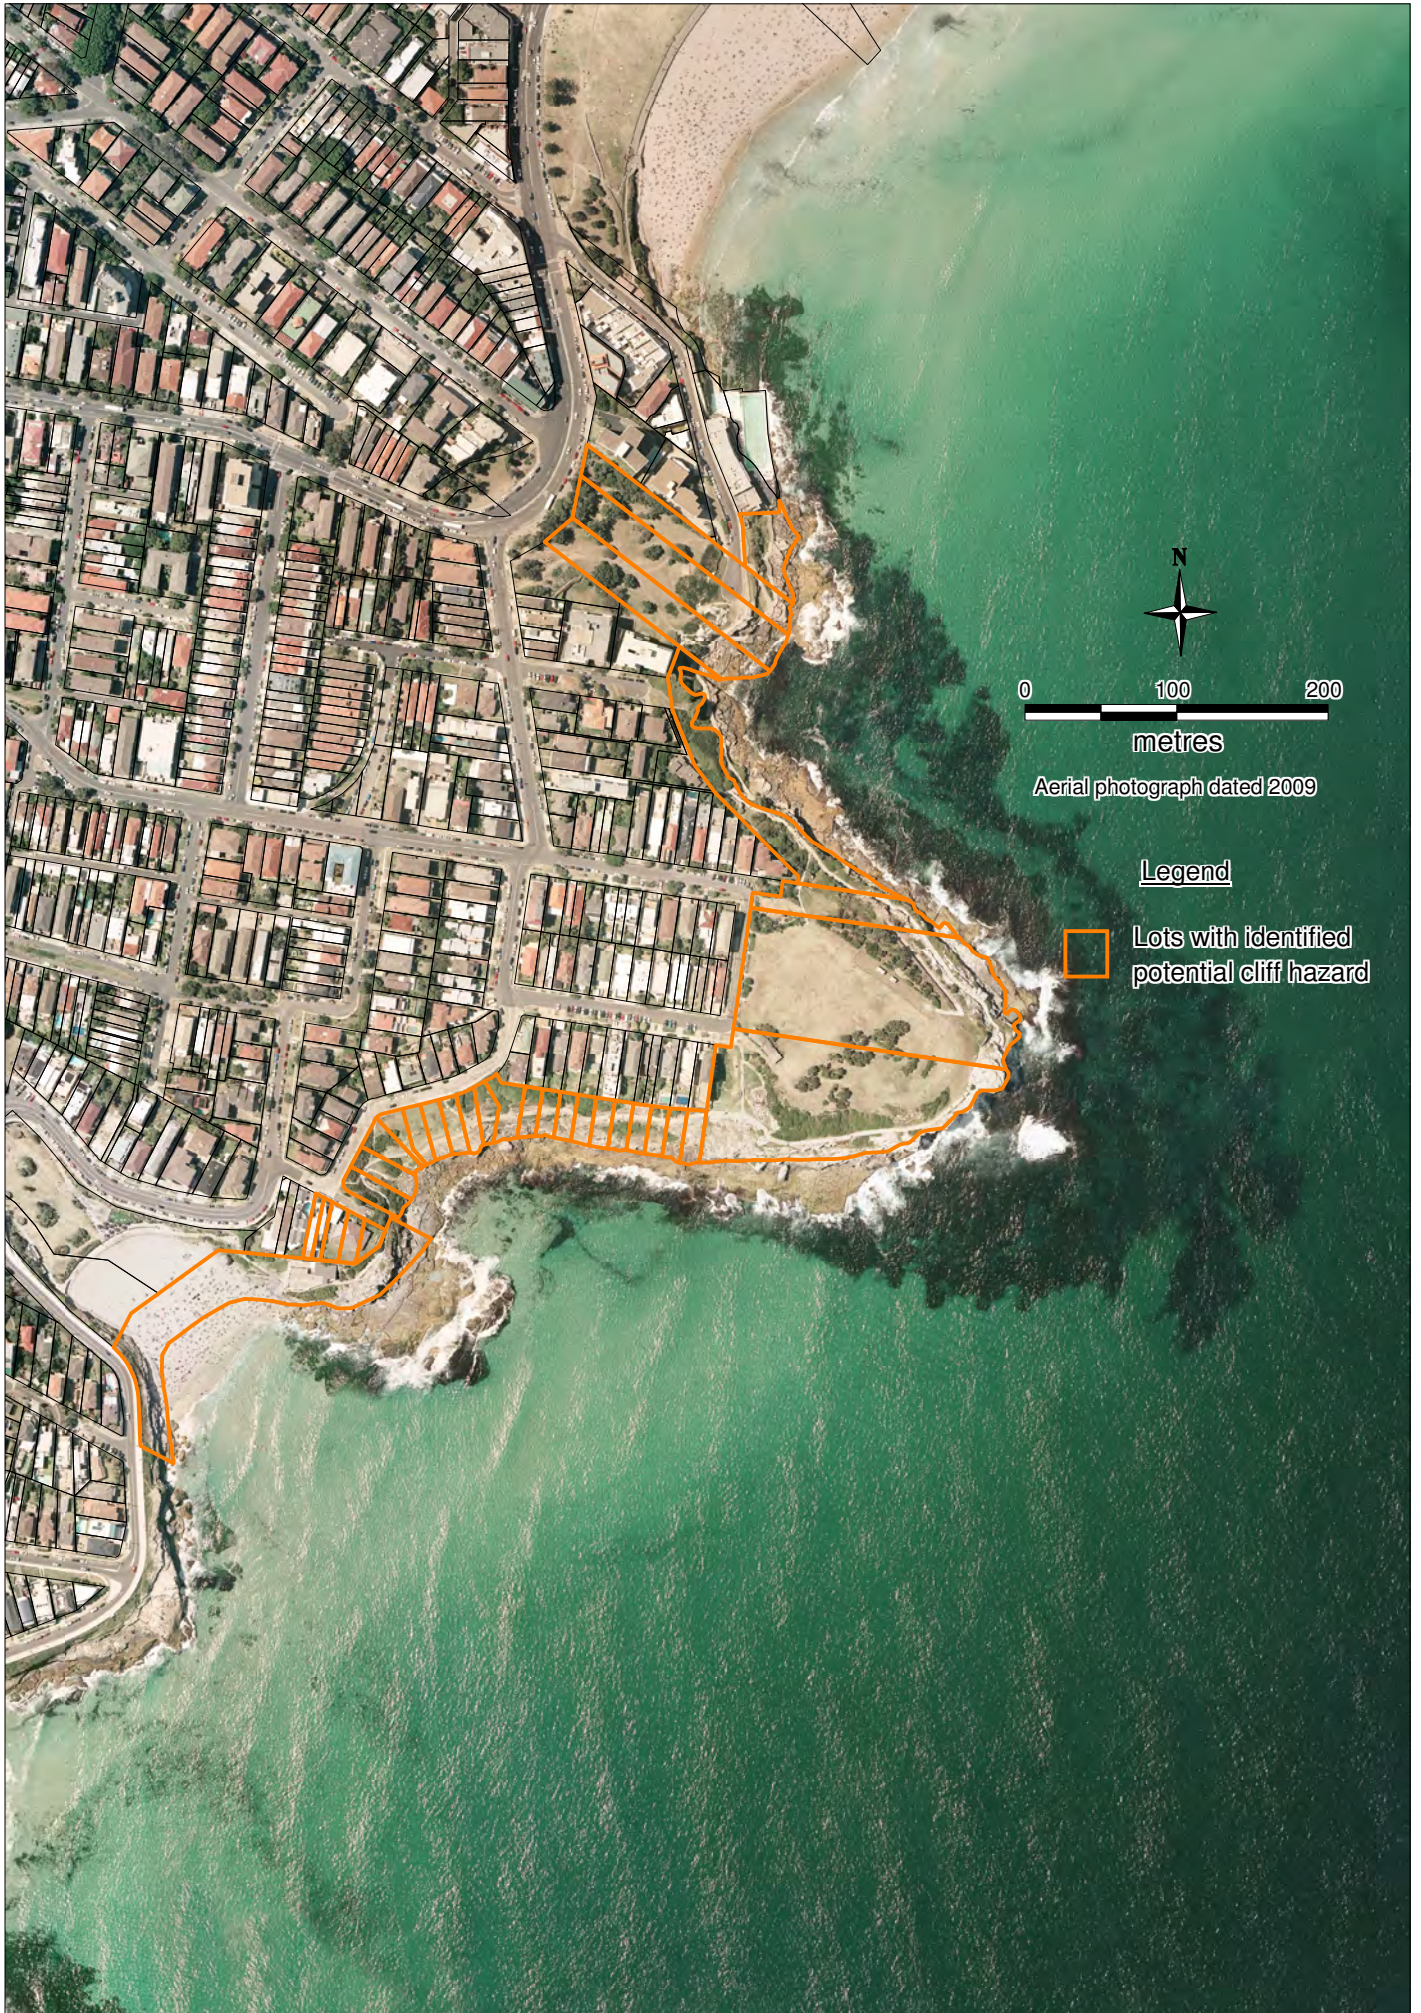
LOTS WITH IDENTIFIED POTENTIAL CLIFF HAZARD (5 OF 6)

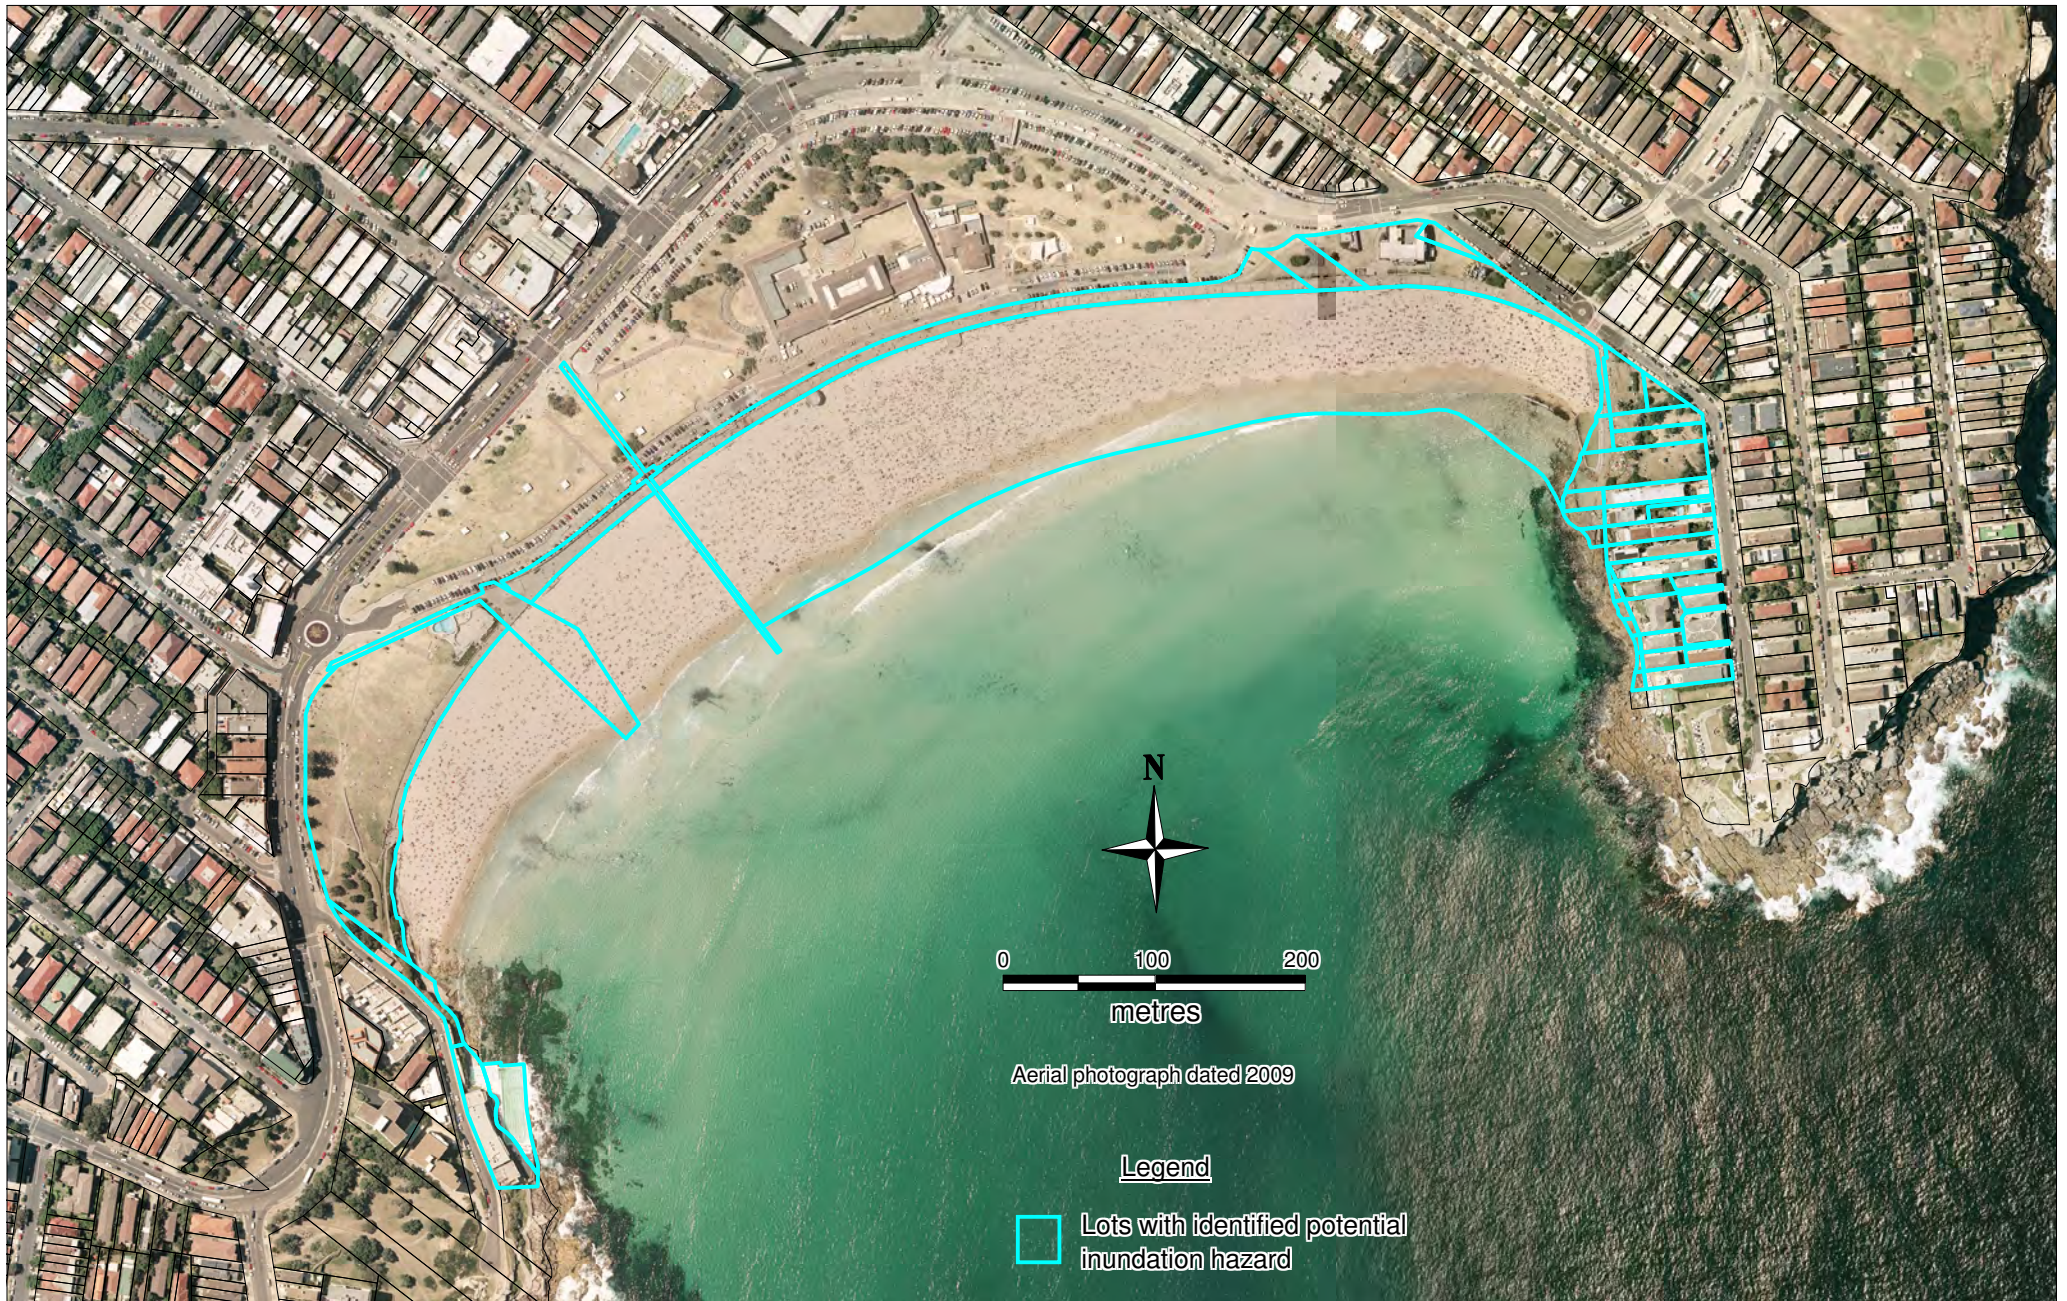
LOTS WITH IDENTIFIED POTENTIAL OCEAN INUNDATION HAZARD (1 OF 3)

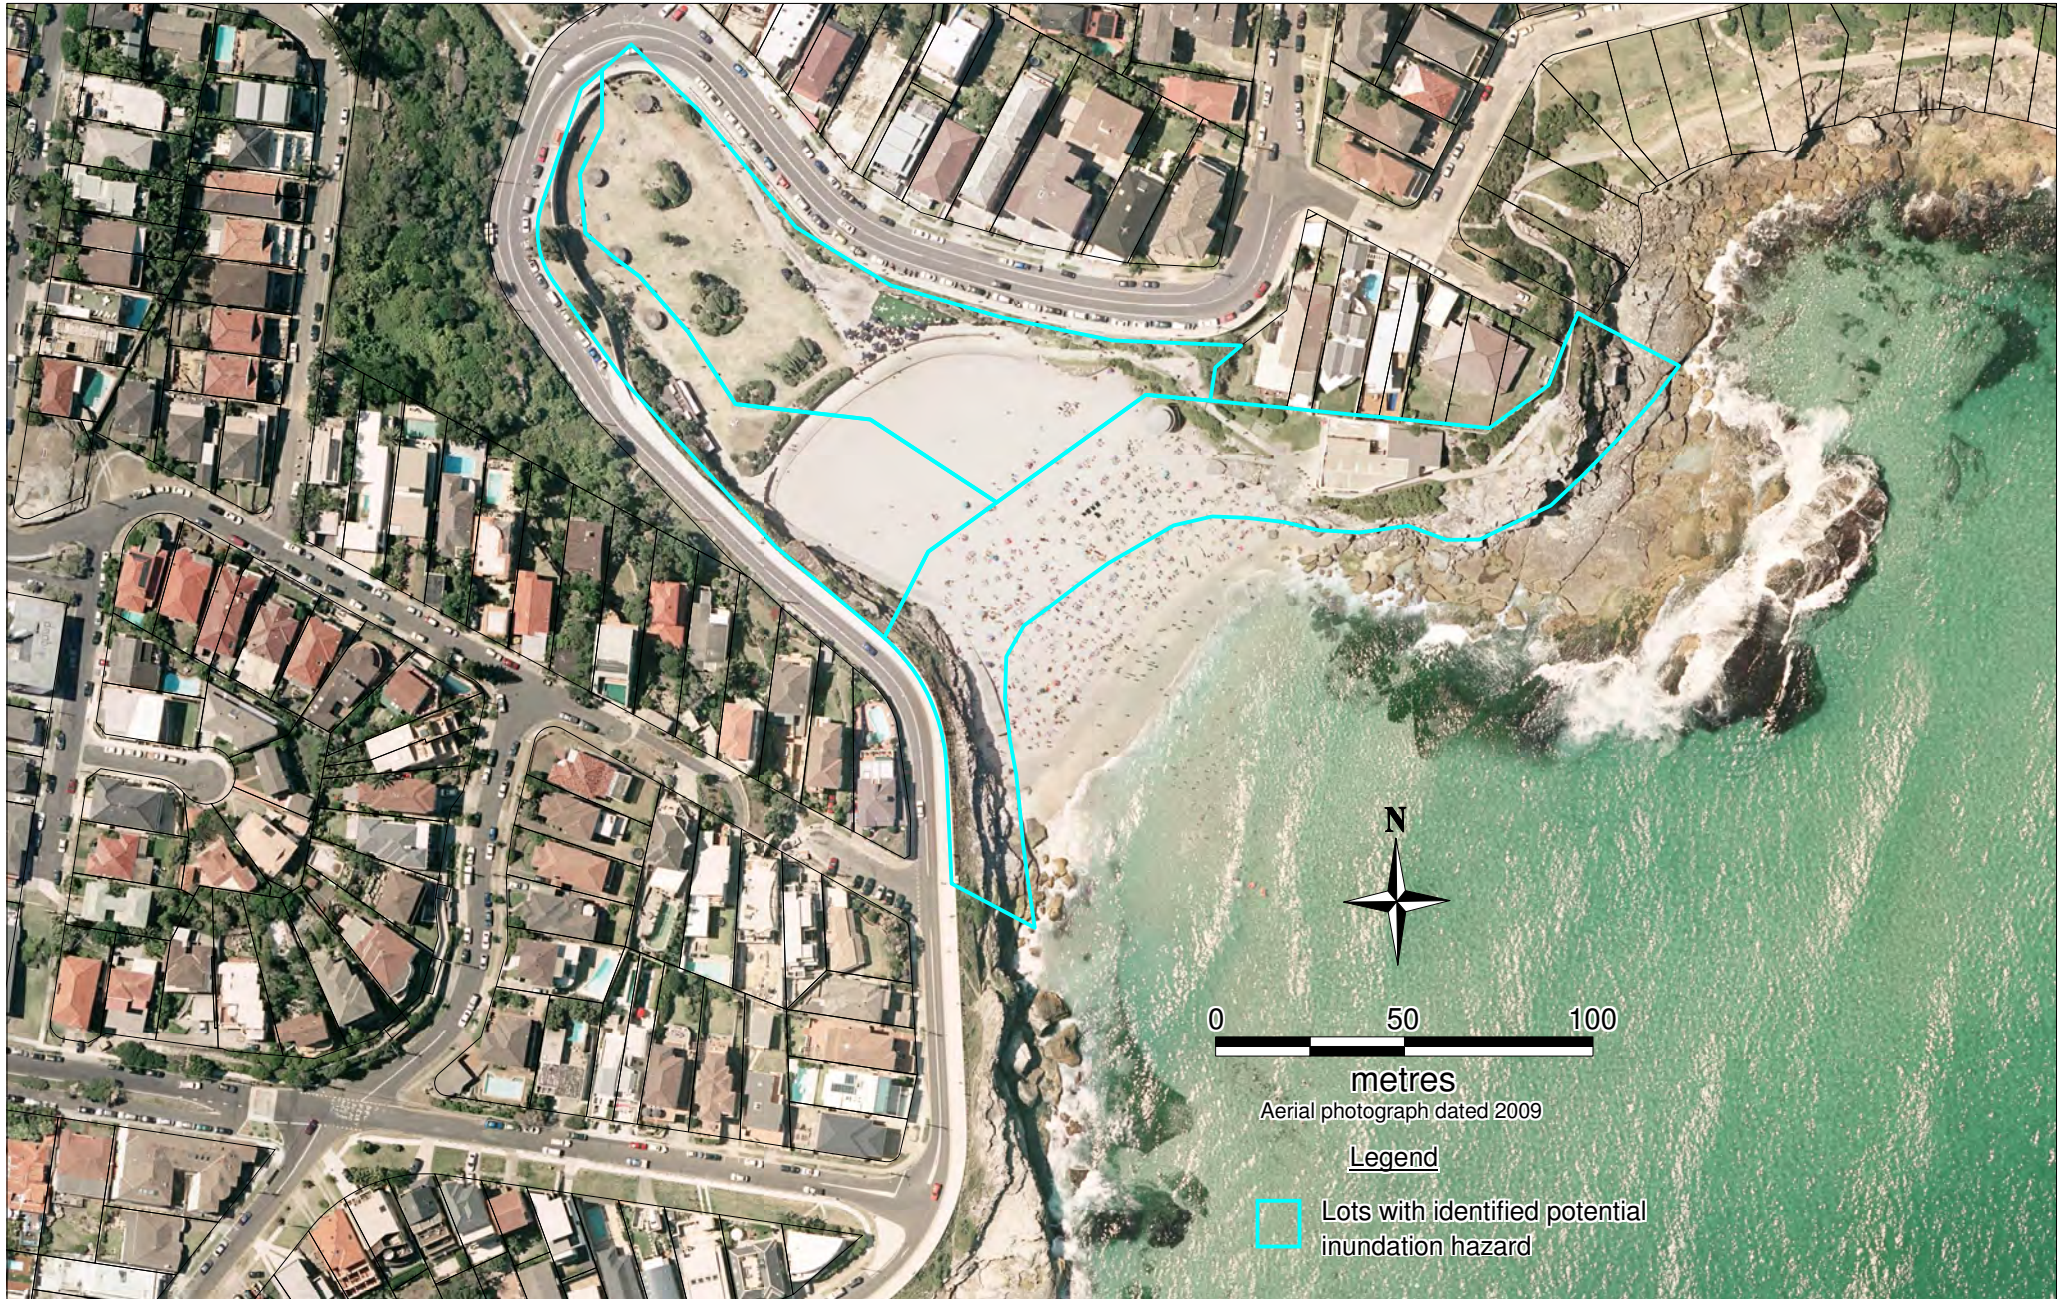
LOTS WITH IDENTIFIED POTENTIAL OCEAN INUNDATION HAZARD (2 OF 3)

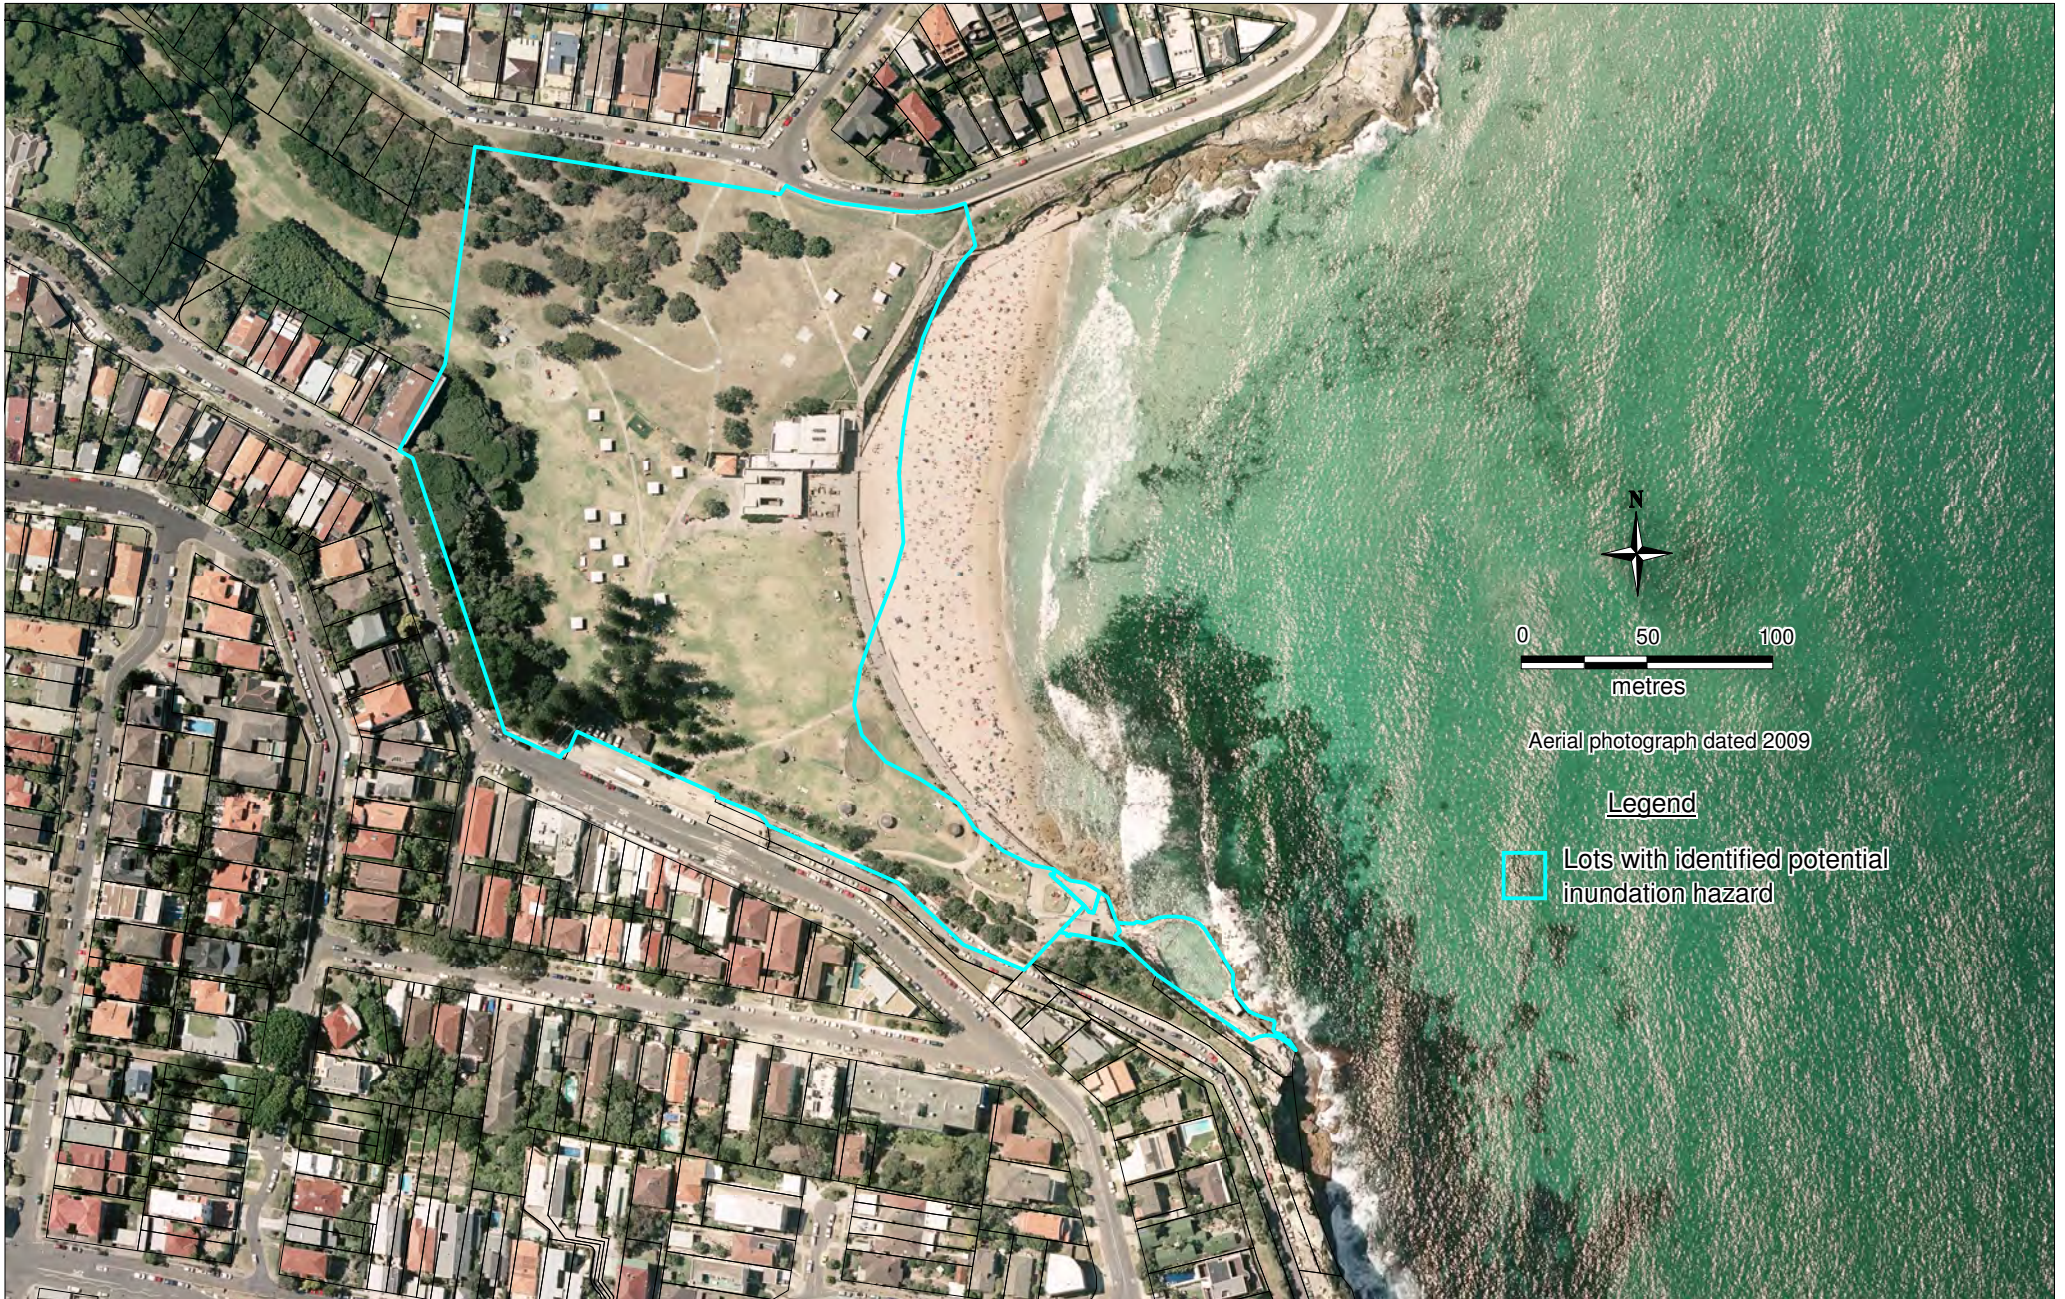
LOTS WITH IDENTIFIED POTENTIAL OCEAN INUNDATION HAZARD (3 OF 3)

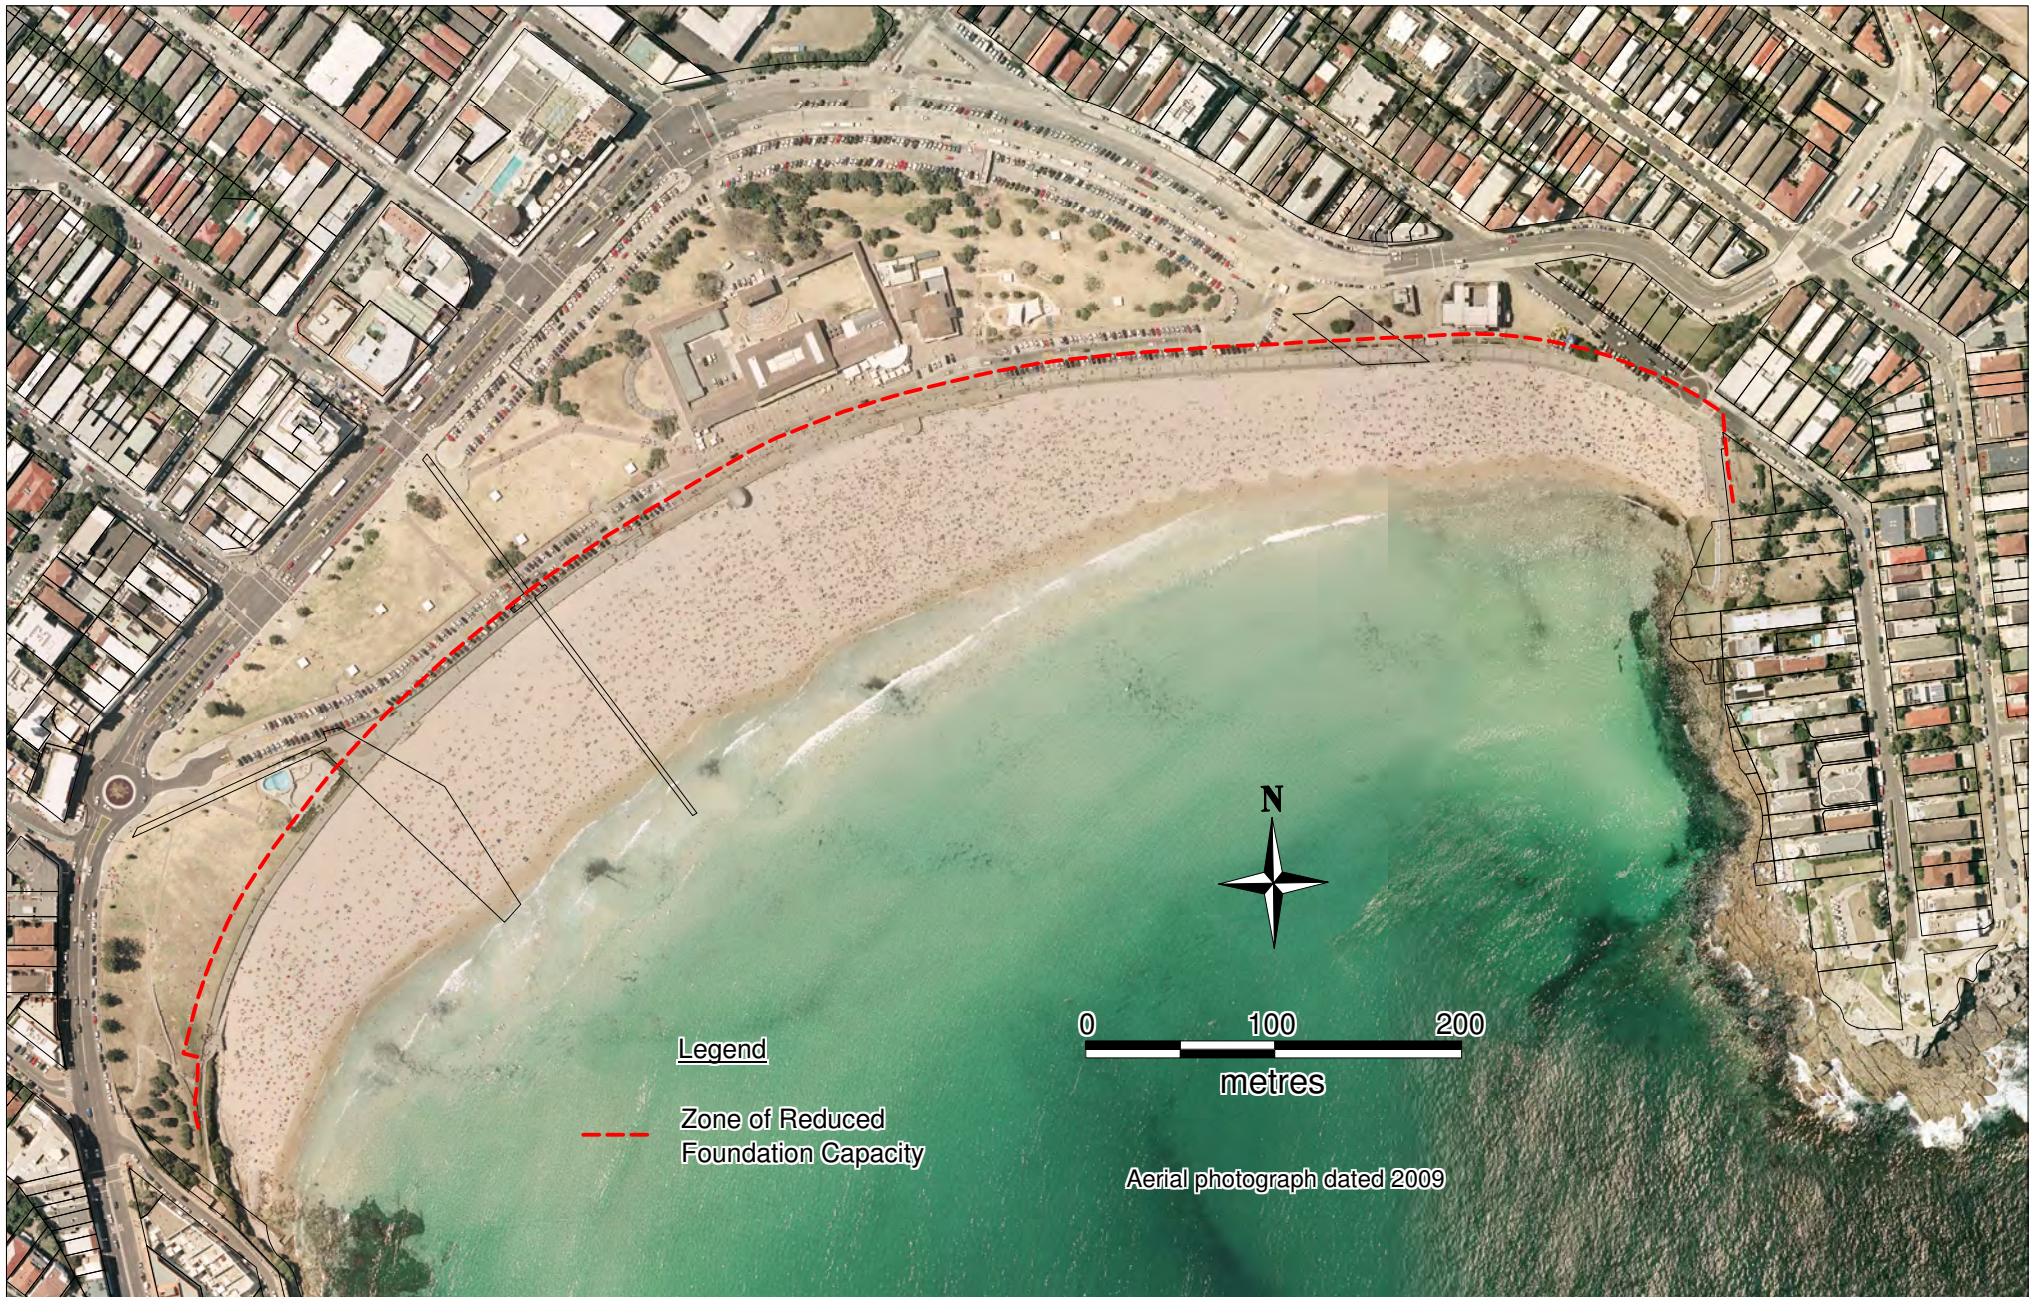
ZONE OF REDUCED FOUNDATION CAPACITY AT BONDI

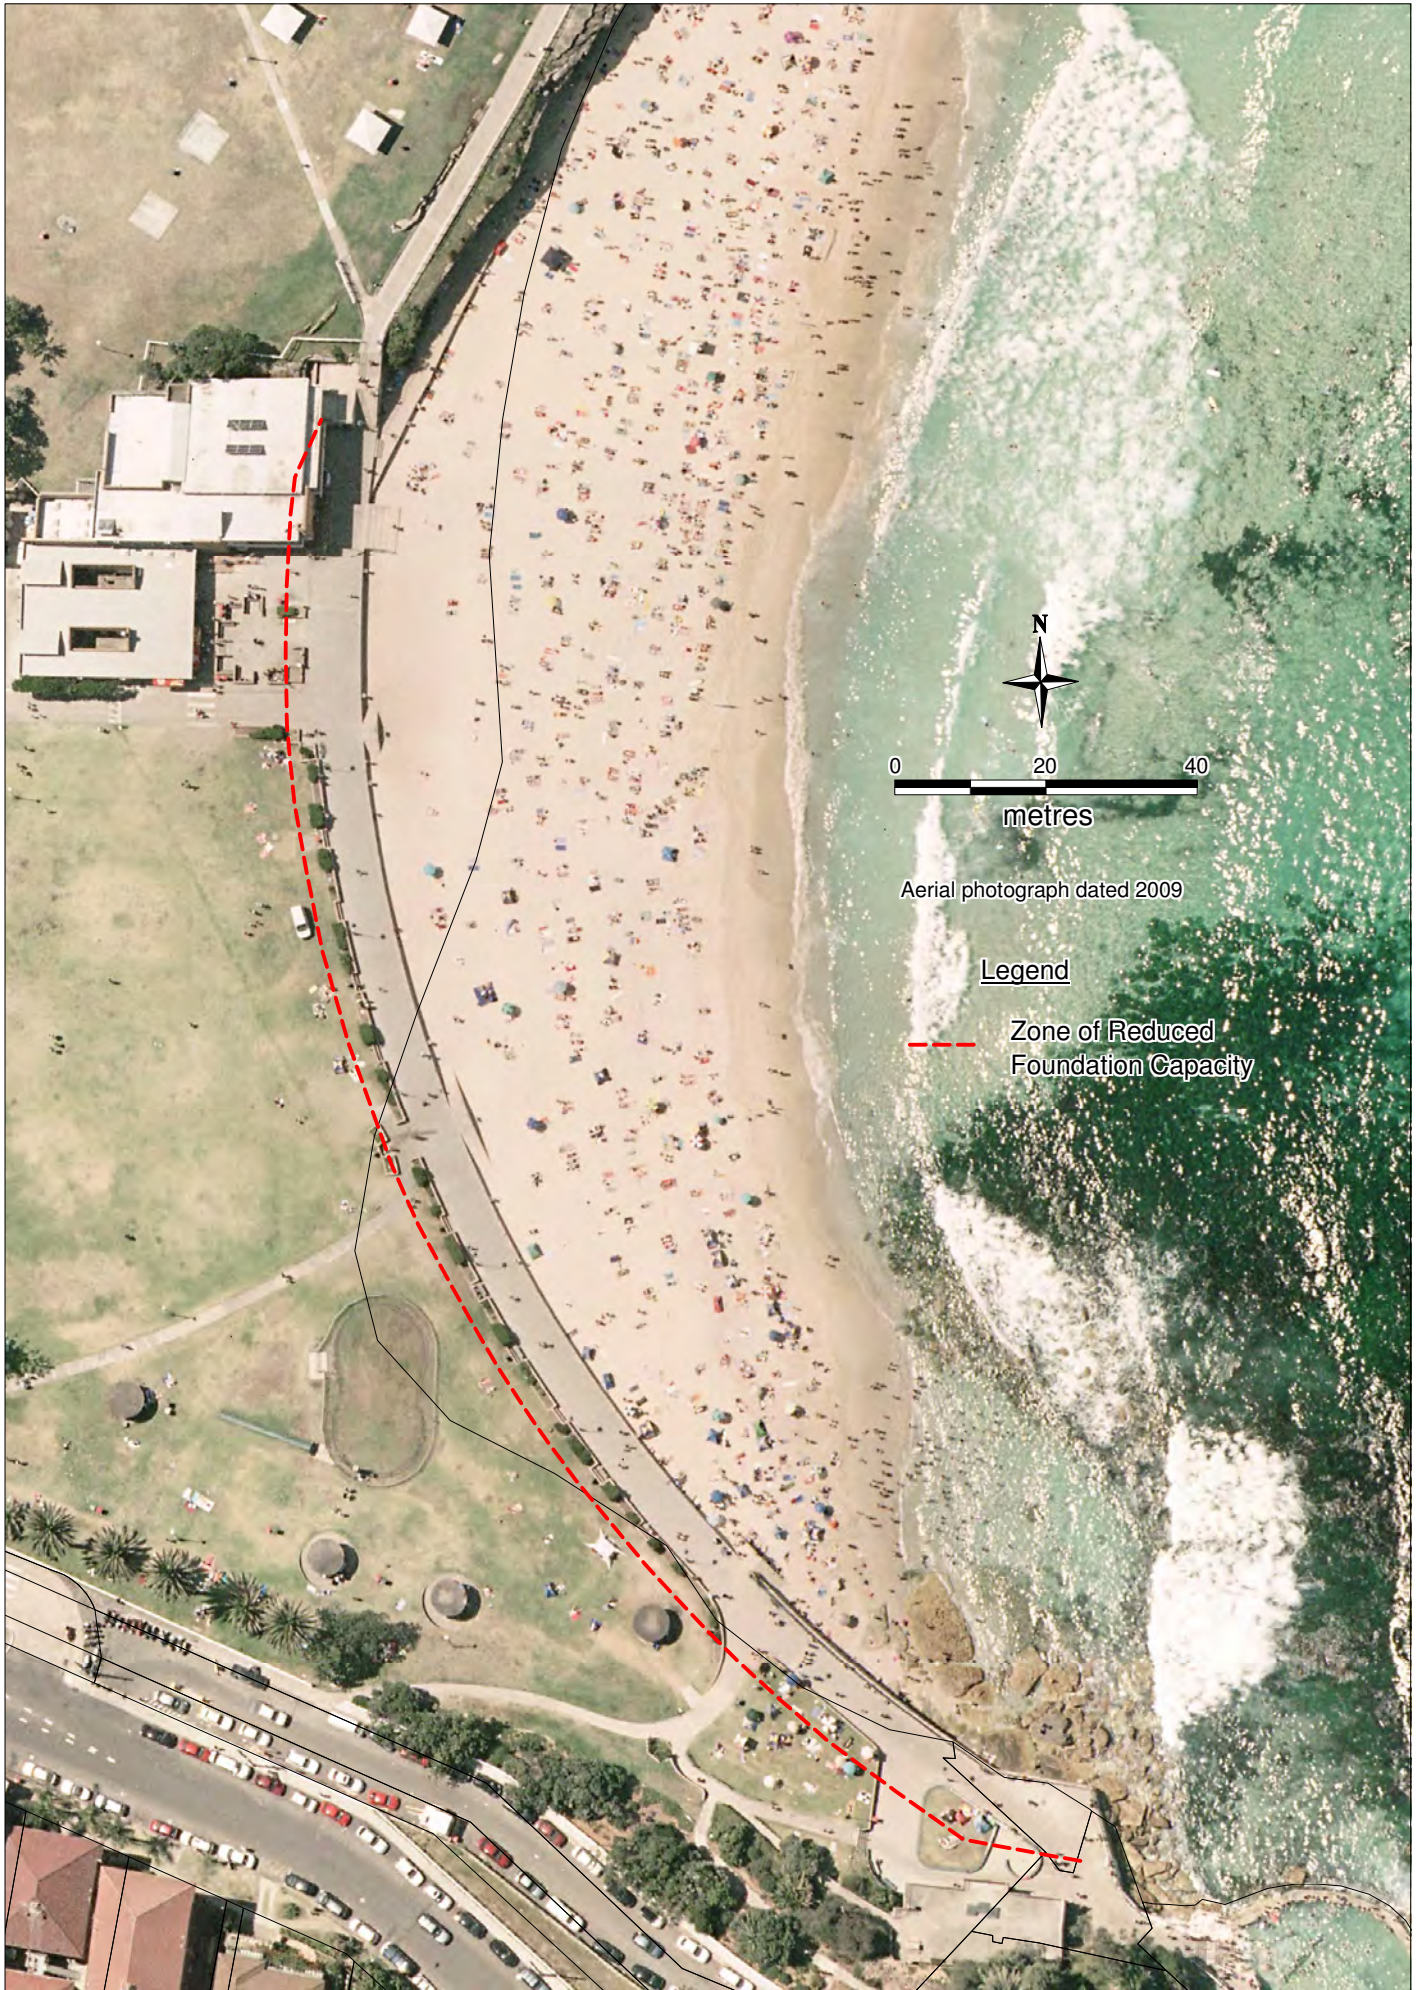
ZONE OF REDUCED FOUNDATION CAPACITY AT BRONTE
